RE: Summary of Evaluation of Remedial Options for Building Debris Removal at
the City of Lorain Former St. Joseph Hospital Assessment Project (Property);
15011.0011.

MEMORANDUM: SUMMARY OF EVALUATION OF REMEDIAL OPTIONS FOR BUILDING DEBRIS REMOVAL
FORMER ST. JOSEPH HOSPITAL REDEVELOPMENT
205 & 208 W 20th STREET, LORAIN, OHIO

Test Pit Investigation

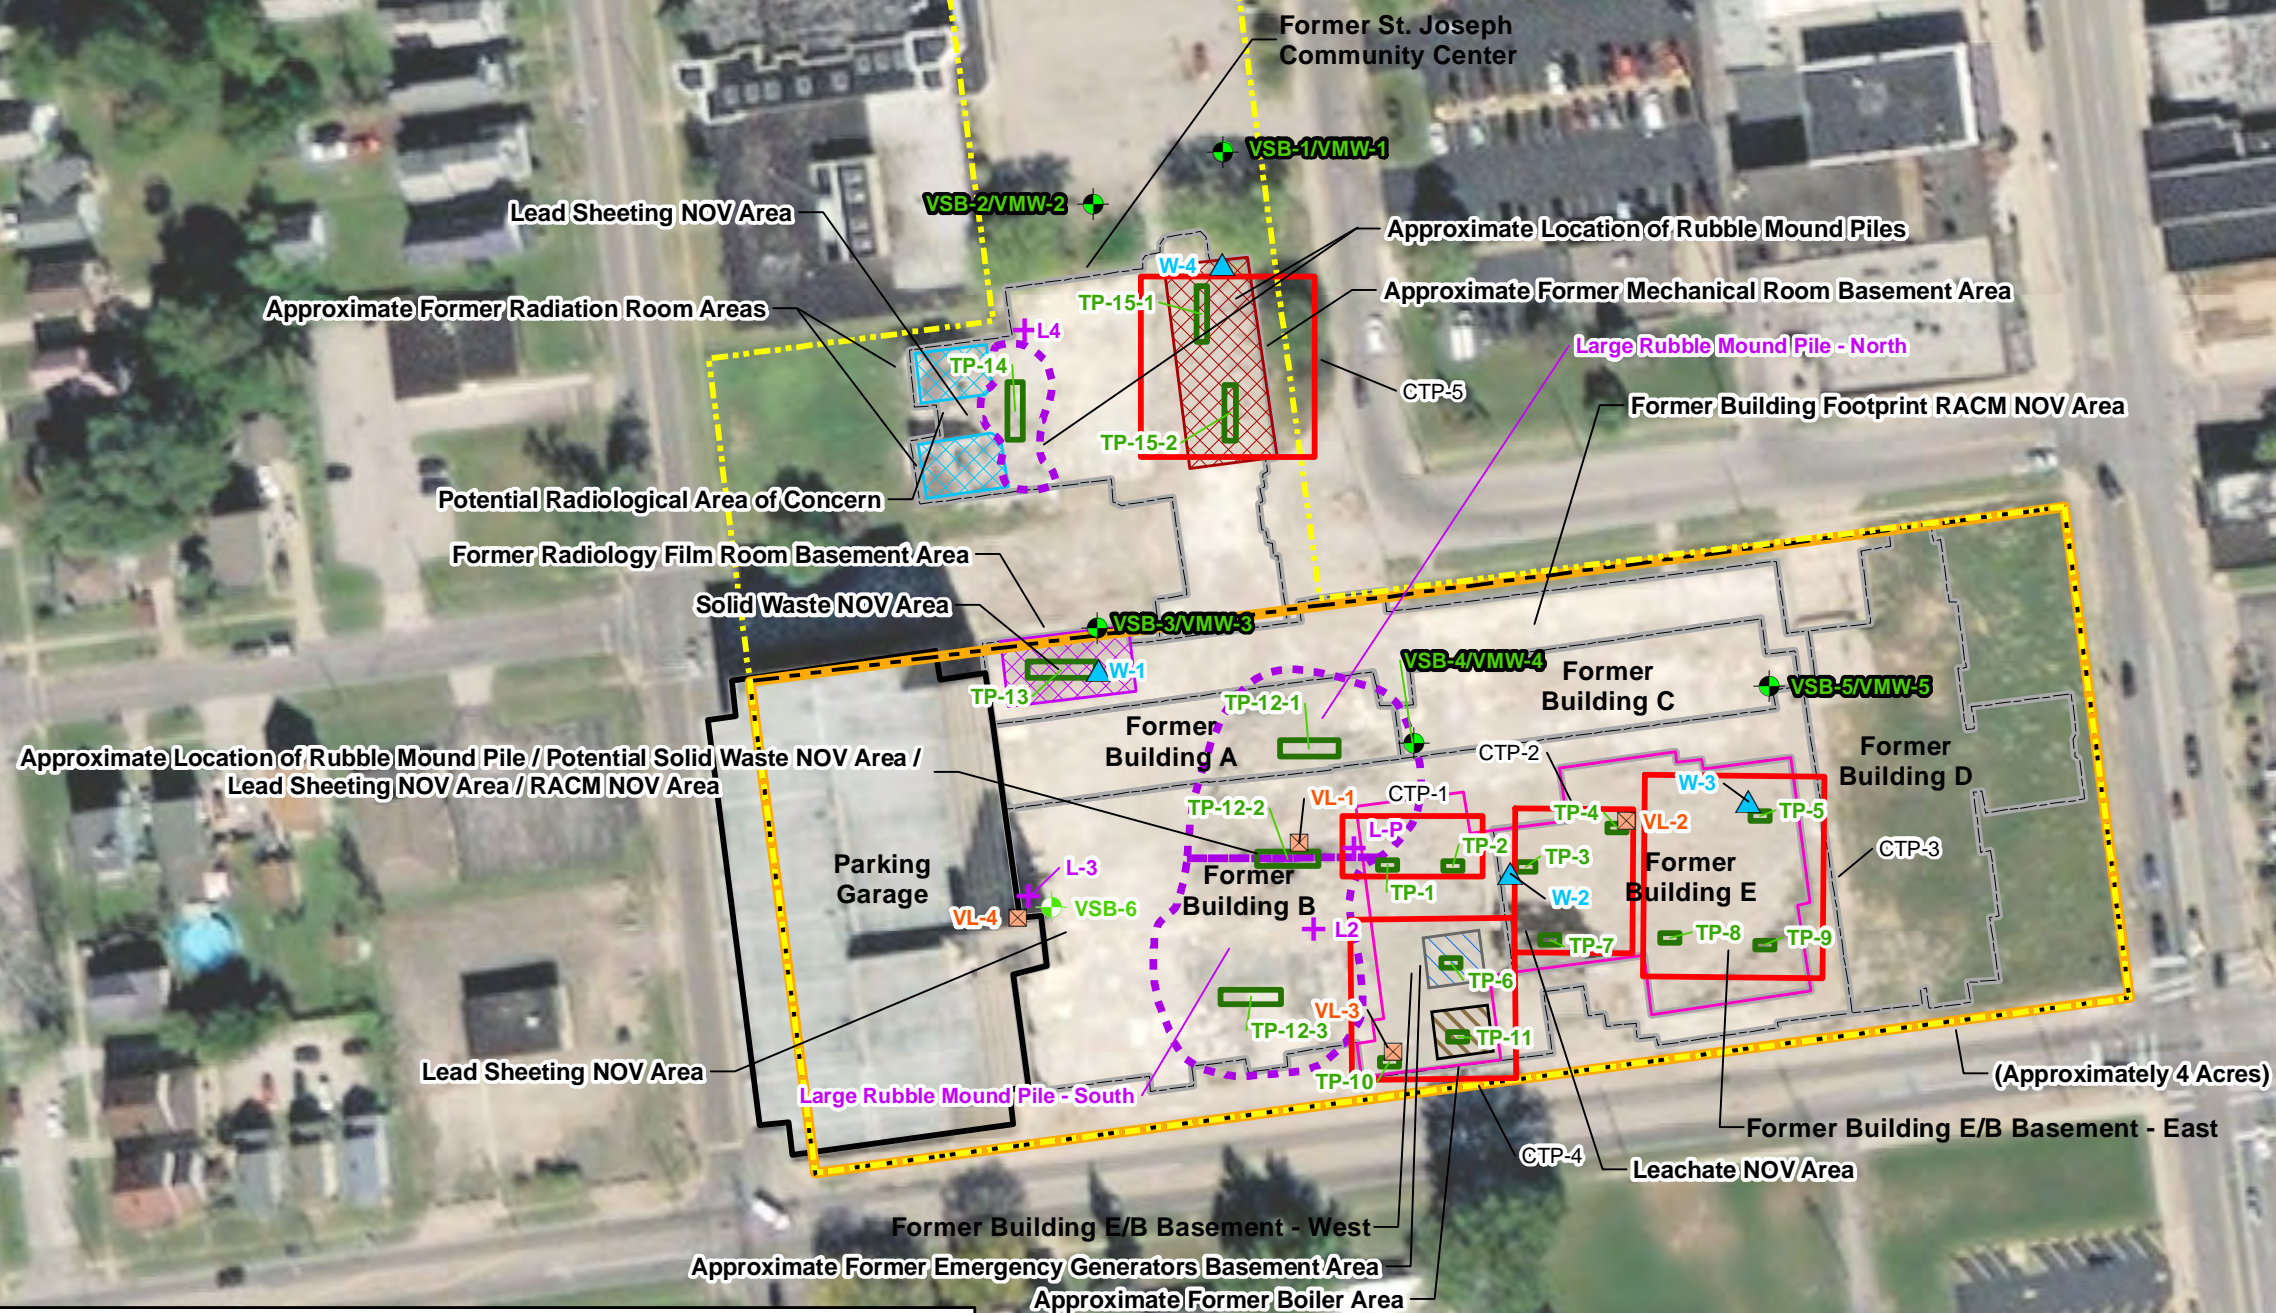
1

Pardee Environmental did identify RACM consisting of transite debris and pipe insulation debris in both the southern section of the large rubble mound pile and the western section of the main basement fill area in the vicinity of test pit TP-2. Pardee estimates that approximately 4,000 cubic yards of RACM is present at the Property, co-mingled within the southern portion of the large rubble mound pile and in the western portion of the Former Building E basement area.

- RACM is present and co-mingled within the southern portion of the large rubble mound pile (TP12-2 and TP12-3) and within the western portion of the Former Building E basement area (CTP-1 and CTP-4). These areas consist of approximately 4,000 cubic yards.

- Universal wastes may be encountered and require additional disposal considerations. However, given that components of light ballasts were observed in only 2 of the 18 test pits (TP-3 and TP-8), the potential to encounter additional universal wastes is considered isolated and nominal.
