Structural Hazzard Assessment Report

Condition Assessment of Parking Garage and Stair/Elevator Tower
at Partially Demolished St. Joseph Hospital and Health Center
205 West 20th Street Lorain, Ohio.

Prepared for
The City of Lorain
May 4, 2022

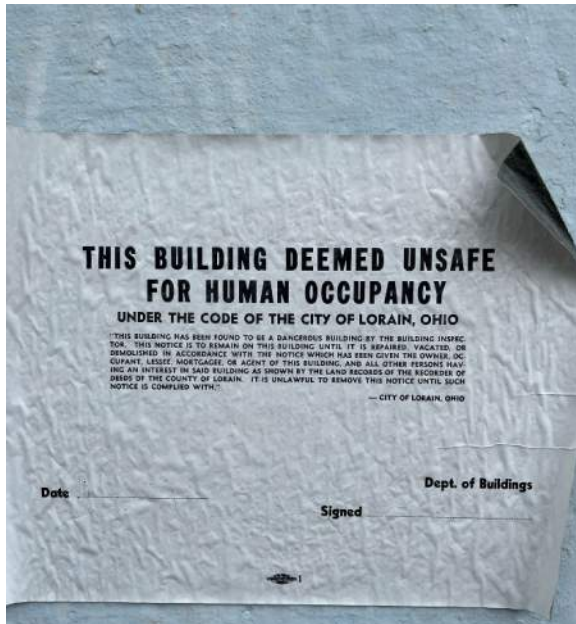
Photo 1: Posting of Unsafe condition for Human Occupancy by the City of Lorain Building Department.

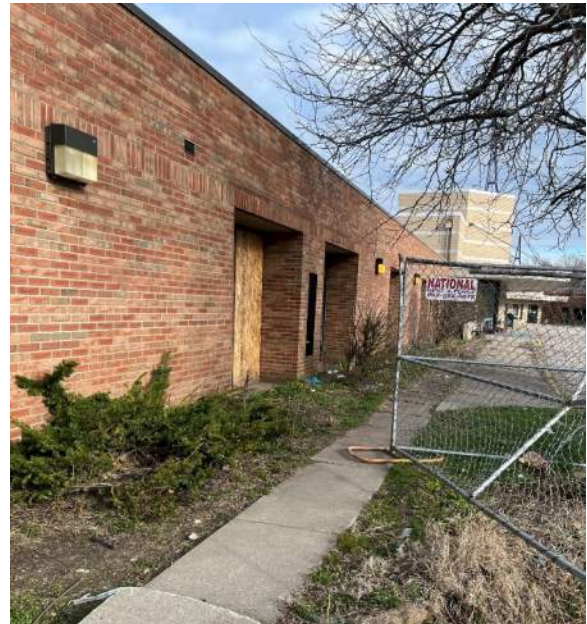
Safety concerns associated with the overall Site include unintended access through fence openings (See Photos 2 & 3), unsatiable debris and pits, partially demolished structures with falling debris or dangerous rubble (See Photos 4 - 8). Pedestrians were observed traversing through the site through the two openings in the fence on the north side of the site. In addition, several observed objects and conditions within the parking structure and stair tower indicate that individuals have occupied the area after demolition.

Photo 2: Incomplete closure of fence at adjacent building to the north of the site.

Osborn observed three pedestrians utilizing the openings in the fence on the north side of the site to cross through. In addition, evidence of squatting/trespassing was observed within the parking and stair tower structures. Due to the presence of multiple life safety concerns Osborn recommends prioritizing improvements to the perimeter fence system.

Due to locals using the north side as a cross through, the fence should be connected rather than extending to the adjacent building to allow for a path outside of the fence. This will reduce the probability that individuals continue to move fence panels allowing for unauthorized access.

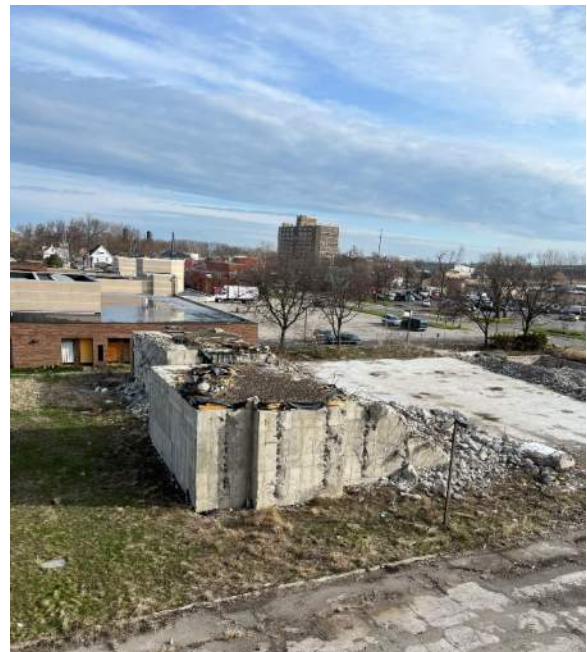
Photo 4: Partially demolished hospital structure on the north side of the site. Exposed portions of embedded rebar and concrete falling hazards exist.

The remaining partially demolished portion of the hospitals structure on the north side of the site, on the east face of the garage, and the remaining sites rubble piles should be removed/demolished. This includes final clean up of the site as well as infill of any below grade voids. Partially demolished structures represent a high risk of falling steel and concrete building elements from remaining elevated structures including roofs. In addition, partially exposed rebar extending from concrete and debris piles can pose safety hazards. This reports primary scope does not include the hospitals' structure or verification of demolition and infill of any below grade voids at basement or vault areas. Additional below grade voids may exist in addition to the observed site pits.

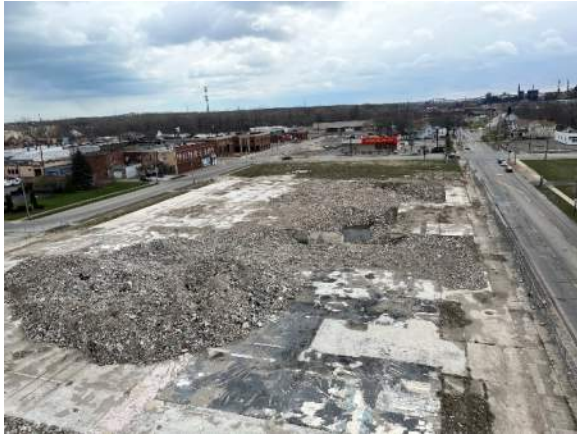
Photo 5: Rubble and debris on site. Open pits, exposed reinforcing, etc. may represent safety hazards.

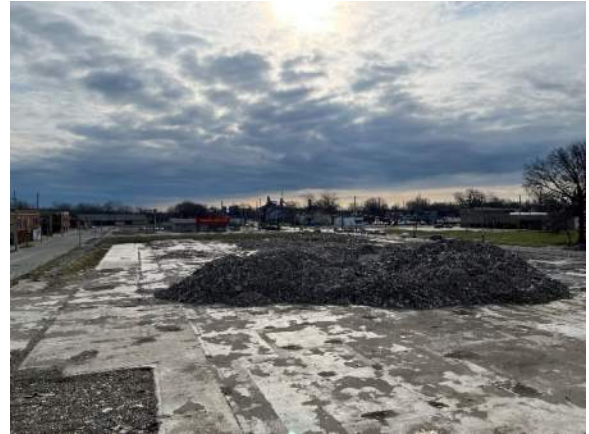
Photo 6: Rubble and debris on site.

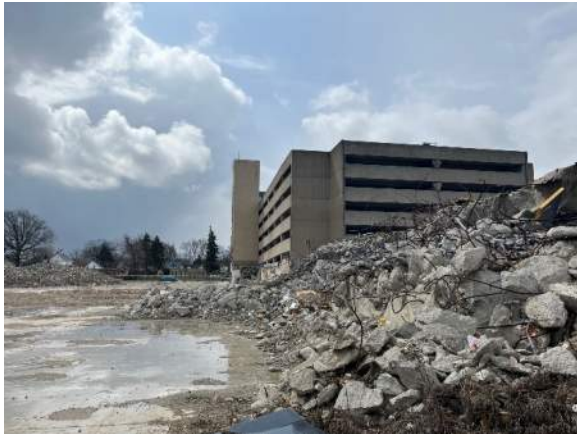
Photo 7: Rubble and debris on site. Exposed reinforcing, falling concrete, etc. may represent safety hazards.

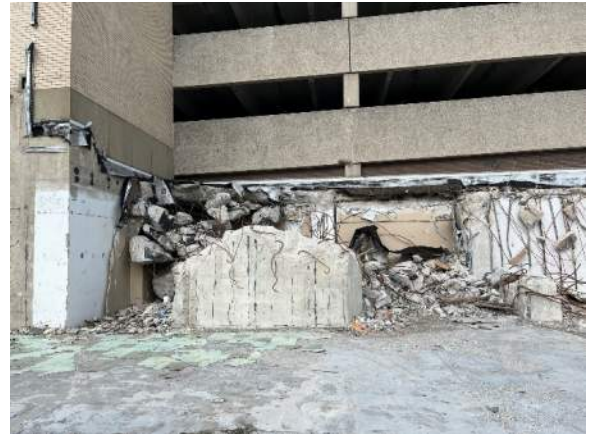
Photo 8: Rubble and debris at partially demolished structure adjacent to parking garage. Falling concrete hazard observed.

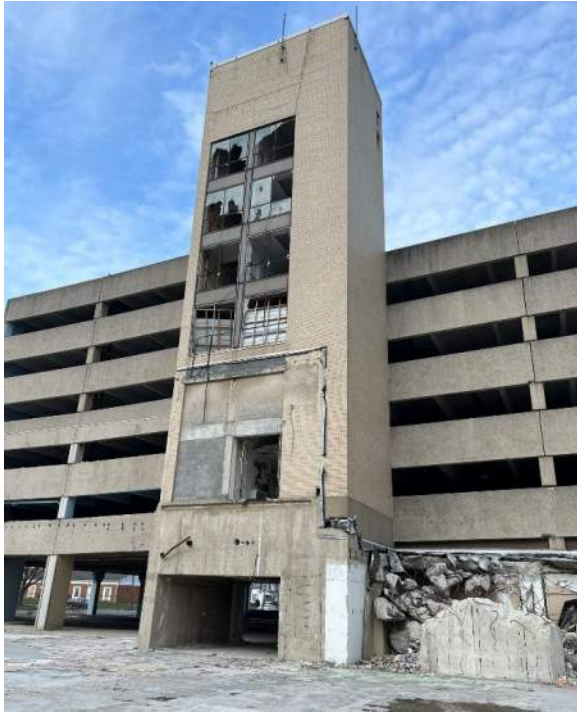
Photo 9: Overall view of east face of elevator/stair tower. Broken window systems do not provide safety closure. Several fall and falling debris hazards exist.

The existing stair and elevator tower has multiple safety concerns/observed hazards. The overall stair/elevator tower's structure is currently capable of supporting itself and could be renovated however it's partially demolished condition and limitations for re-use may justify demolition and reconstruction if the parking structure were to be repaired and renovated. Pending decisions regarding the overall site's future plans, the existing safety hazards should be addressed. These include demolition and removal of the remaining portions of the low roof flashing, window systems, and at grade adjacent structures. In addition to demolition, all access doors should be re-sealed. Where openings at windows or abandoned exits to the demolished hospital exist, closure/fall protection barriers should be constructed. The existing roof hatch should also be secured to prevent roof access and reduce water intrusion.

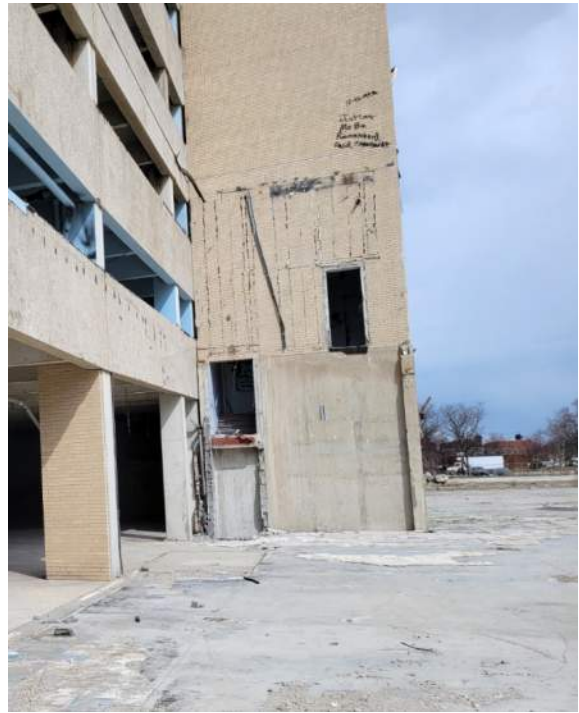
Photo 10: South face of stair tower has two unsecured openings a previous entry to the demolished hospital. Dislodged low roof flashing exists.

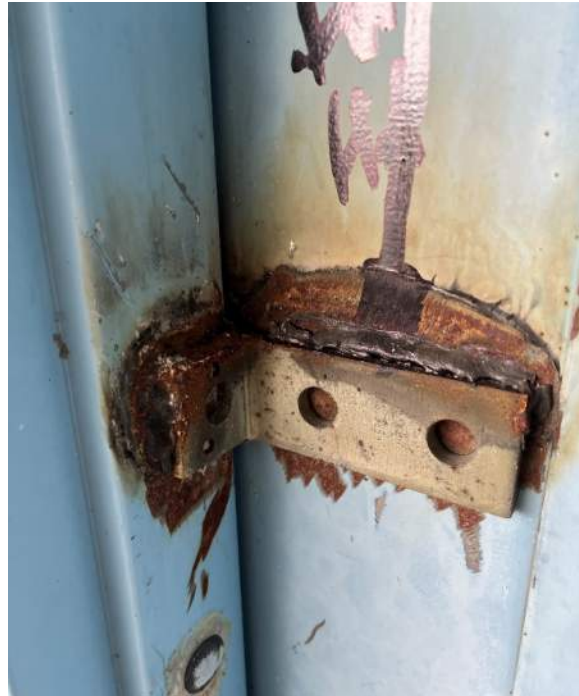
Photo 12: Typical welded shut elevator lobby door (from inside garage).

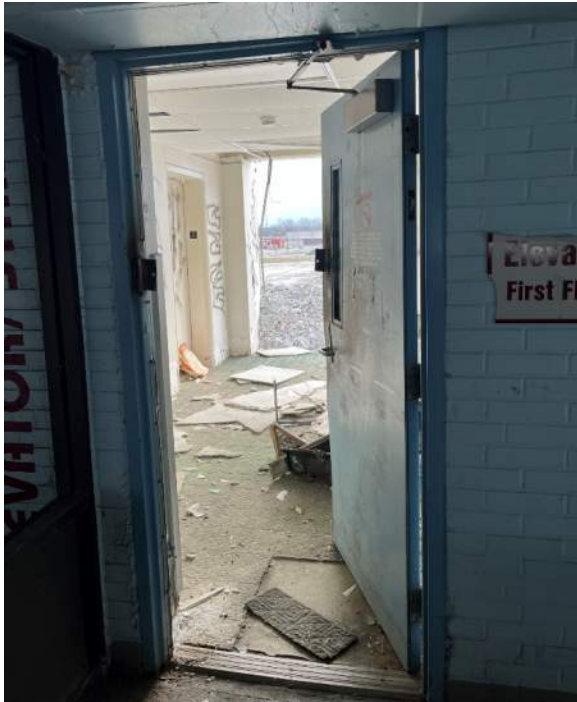
Photo 13: Unsecured Elevator lobby door. Weld plate dislodged.

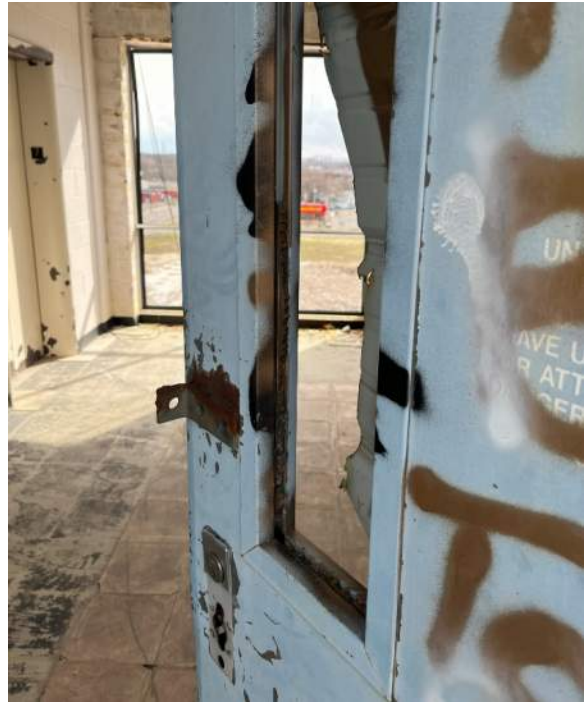
Photo 14: Unsecured elevator lobby door. Weld plate dislodged.

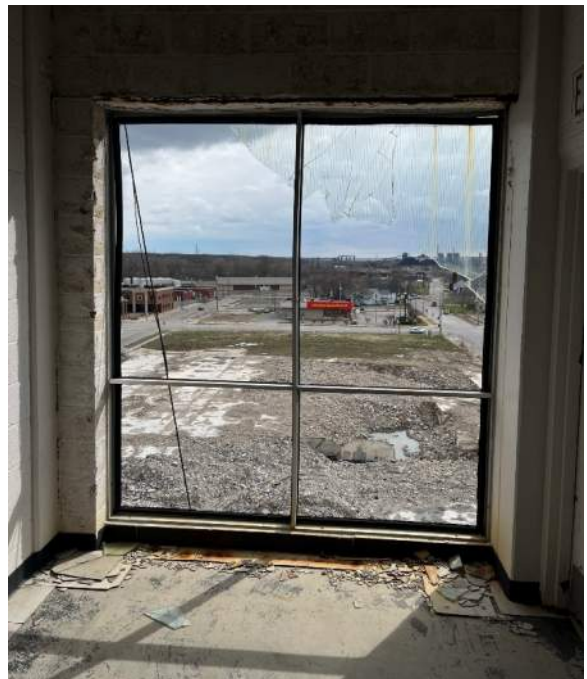
Photo 16: Broken out window system. Fall hazard at accessible area of elevator lobby.

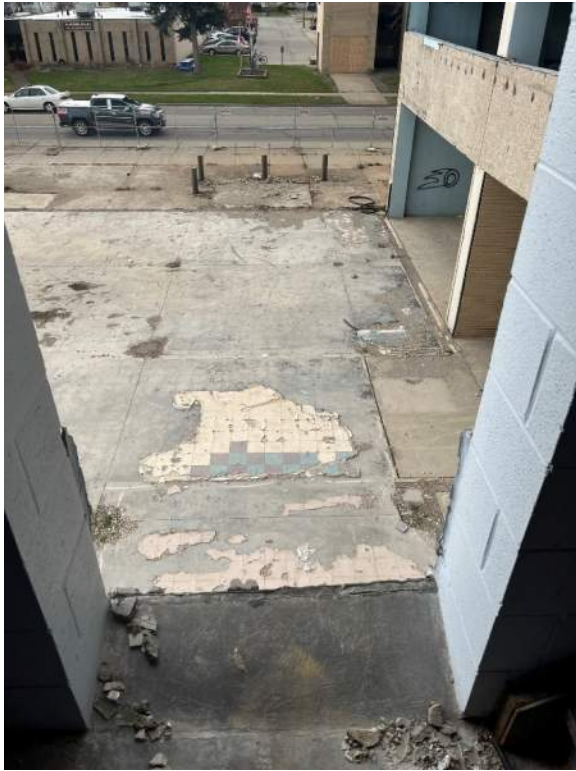
Photo 17: Unsecured exist at bottom of stair at 2nd floor. Fall hazard to grade.

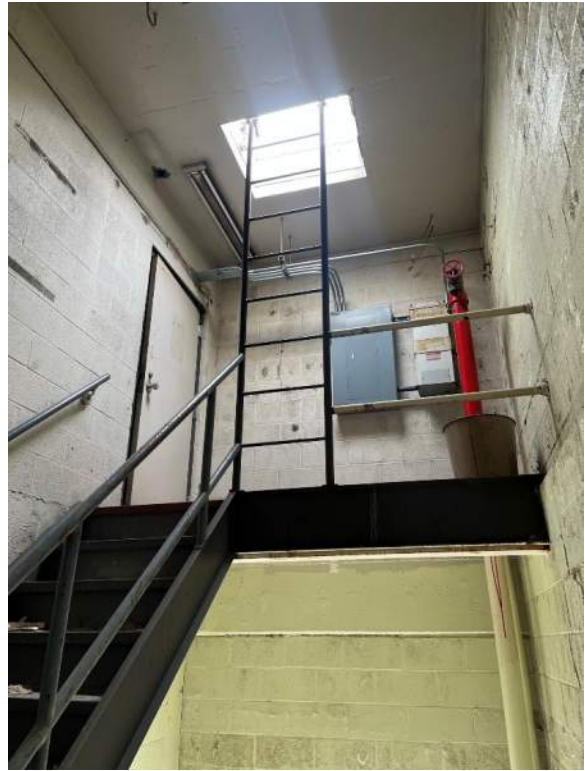
The existing guard/handrail system of the stair tower were observed to lack code defined closure allowing greater than 4" gaps. The existing guardrail system would require replacement to allow re-use of the structure. In addition, the roof hatch was observed to be open, its operability was not assessed due to uncertainty in the stability of the existing ladder system. See photos 18 & 19 for typical conditions of railing and hatch conditions.

Photo 18: Unsecured roof access hatch at stair tower. Improper closure of hand/guardrail system.

If the existing stair and elevator tower were to be reused, replacement of the existing hand and guardrails system would be required. In addition, installation of a new window/glazing system would be required at each level. At level 2, the stair would need to continue to grade for egress. Recommendations for mechanical, electrical, and architectural elements for this area are beyond the scope of this report.

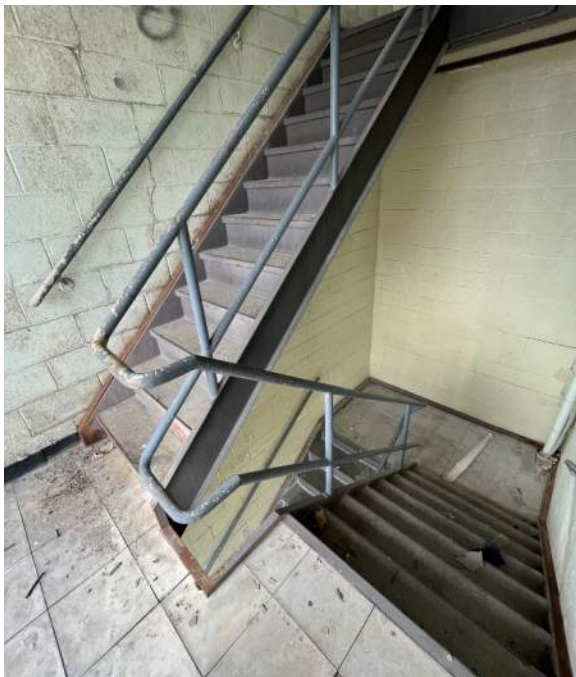
Photo 19: Improper closure of handrail system at stair.

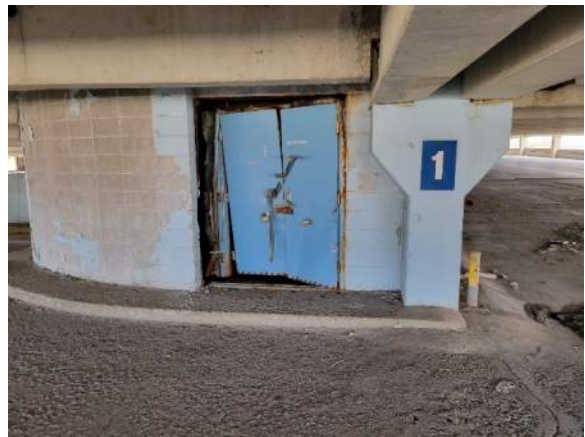
Photo 20: Damaged door at mechanical area at level 1 mechanical room.

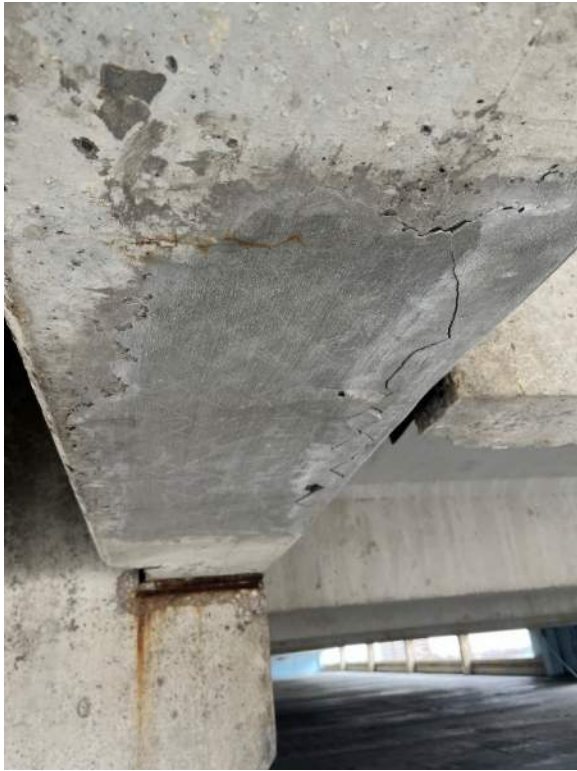
The precast beams and cast-in-place concrete columns are in general in Good to Fair condition with select areas experiencing deterioration (See Photos 21 - 29). Select locations of both beams and columns have experienced moderate to severe spalling however these conditions were observed to be isolated.

Photo 21: Typical moderate beam spall

If the parking structure is to remain unused for a period of time, Osborn recommends select repairs be completed within the next 6 months to prevent loss of capacity for design loads. This includes select repair of concrete at columns, beams, precast T joist stems, and slabs. These recommended repairs focus on primary structural members for moment and shear capacity at service levels.

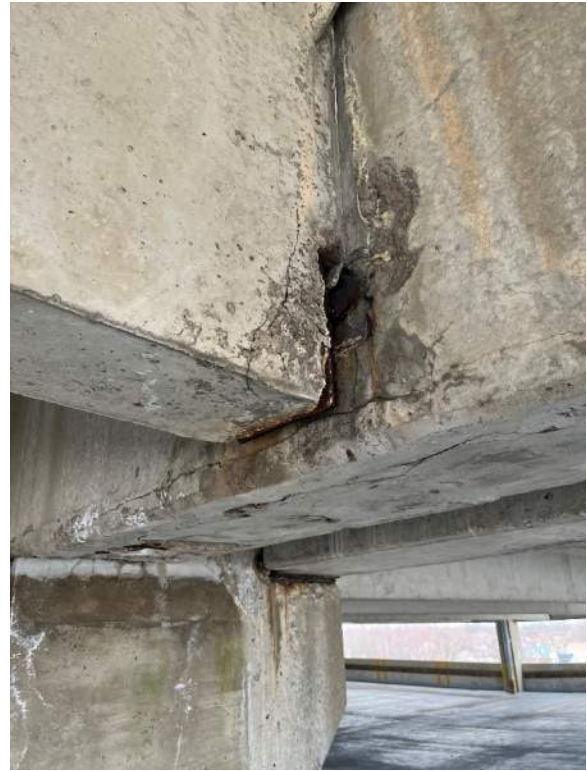
Photo 22: Typical moderate to severe beam spall at joist bearing. Moderate joist stem spall.

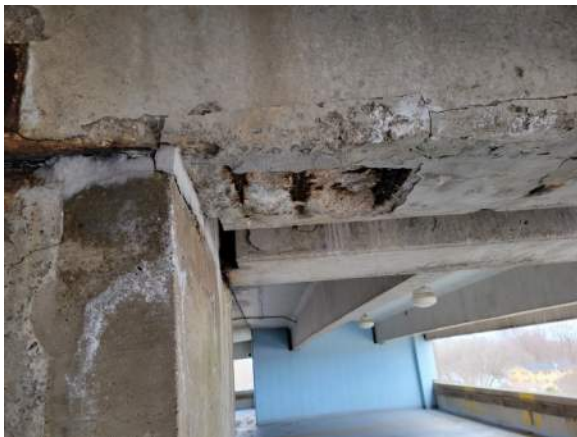
Photo 23: Typical severe beam spall at bearing at column. Efflorescence from de-icing chemicals observed and corroded exposed reinforcing steel.

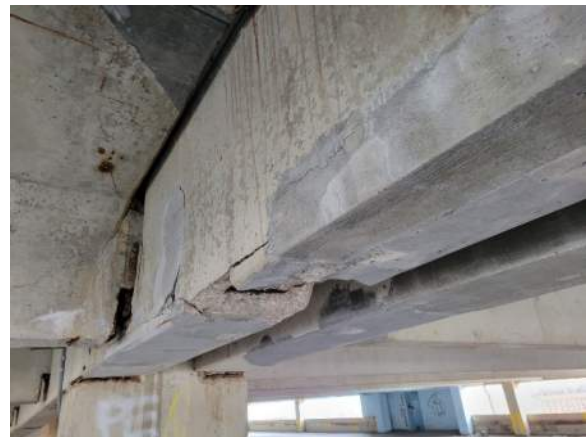
Photo 24: Typical severe beam spall at previous repair.

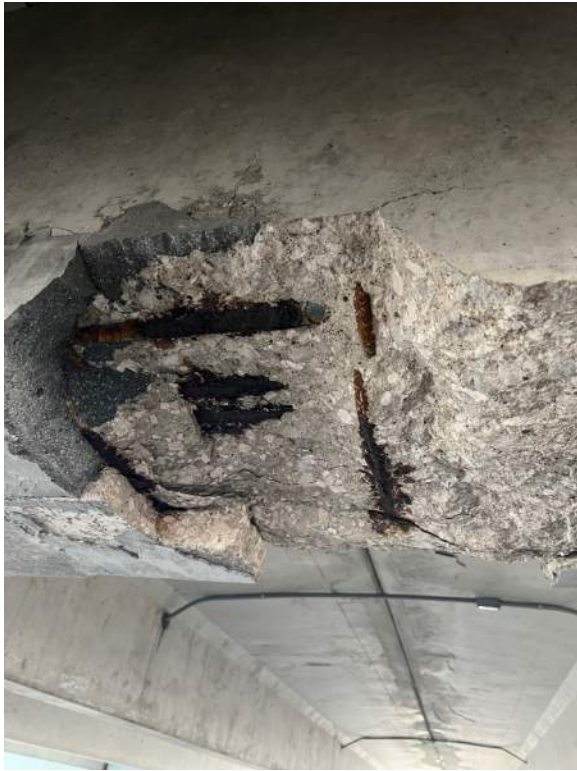
Photo 25: Severe beam spall with exposed corroded reinforcing. spalling of previous repair observed.

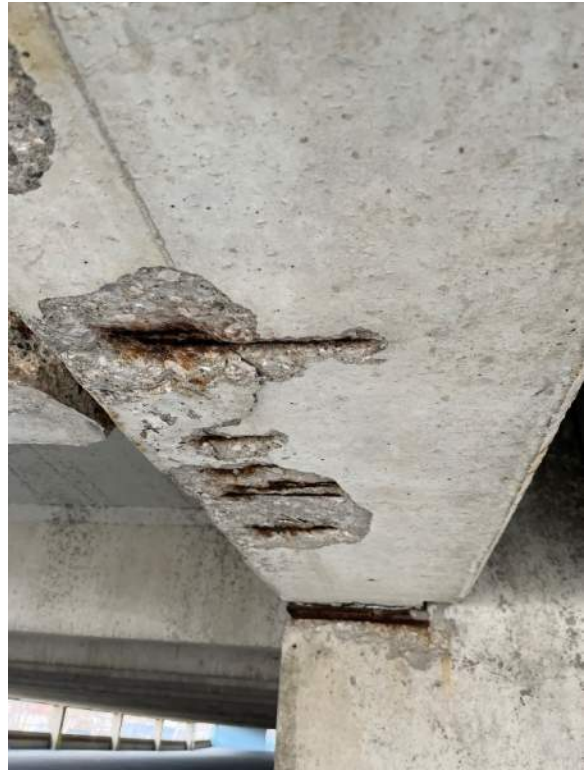
Photo 26: Spalling of beam at stirrups.

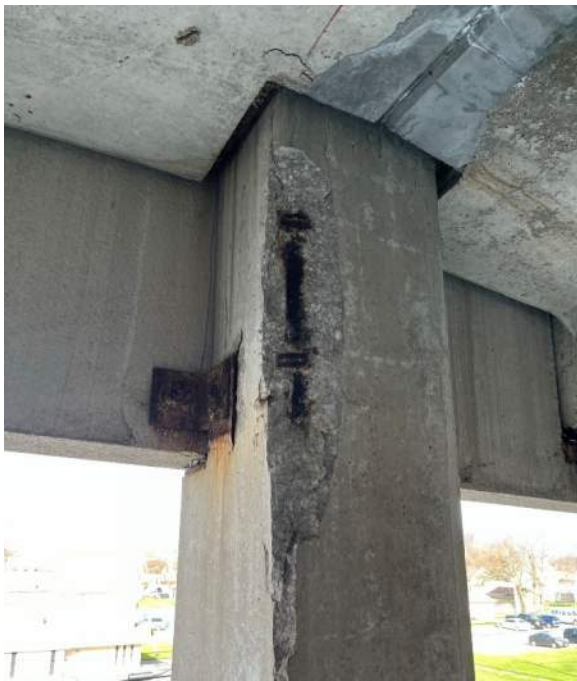
Photo 27: Typical moderate column spall.

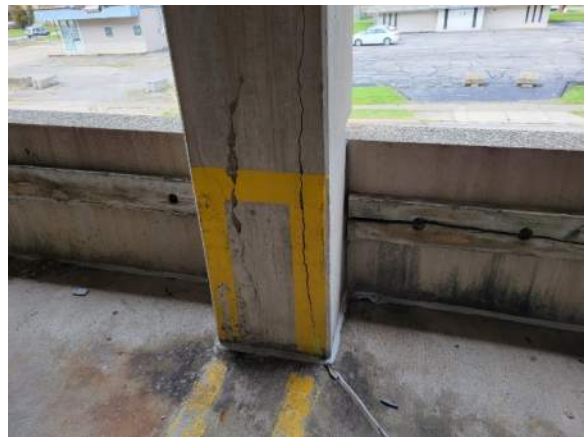
Photo 28: Typical minor to moderate column spall.

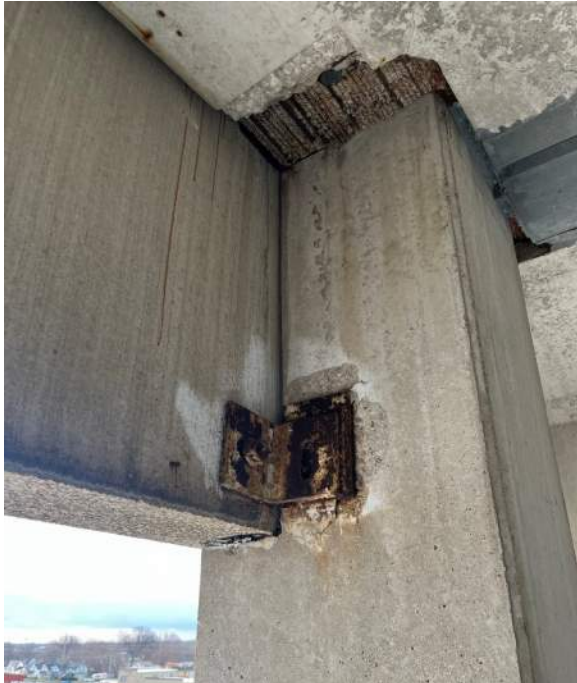
Photo 29: Minor columns spall at corroded precast beam anchor.

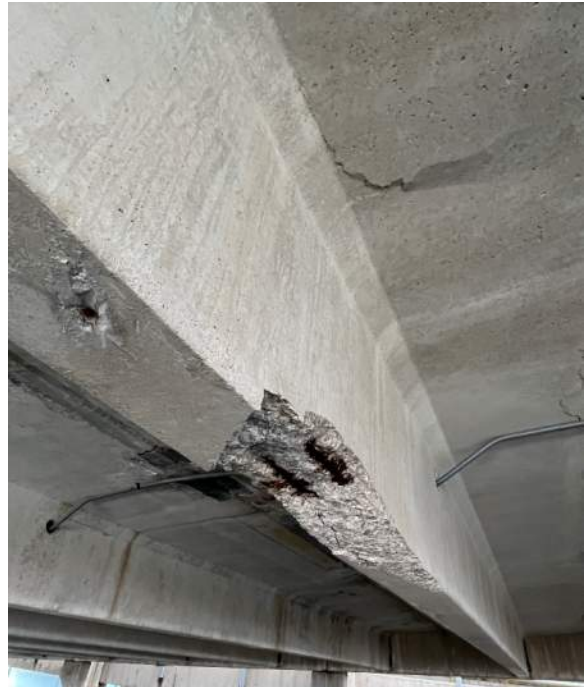
The Precast T's joist stems are in general in Fair condition with select areas experiencing deterioration typically at bearing locations (See Photos 30 - 33). Some deteriorated areas were observed to have occurred at previous repairs. These locations exhibit substantial corrosion of reinforcing steel and may have been repaired using subpar quality techniques including a lack of corrosion inhibiting bonding agents and poor edge conditioning of patches. These conditions can lead to premature and rapid deterioration of repaired areas.

Photo 30: Typical severe spall at joist stem. Exposed corroded reinforcing.

In order to return the structure to use, additional structural repairs would be required at slabs and precast T joist stems. These repairs would focus on local elements for design loads at drive and parking areas. In addition, to slow the rate of deterioration of concrete elements and prolong the usable life of the structure, replacement/repair of the epoxy overlay waterproofing system and deteriorated drainage elements would be required to make re-use of the parking structure economically viable in the long term.

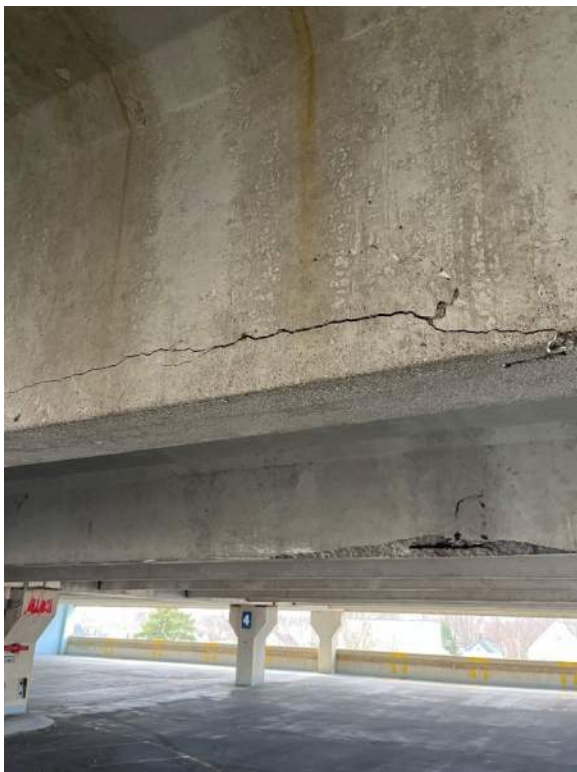
Photo 31: Typical delaminated joist stem.

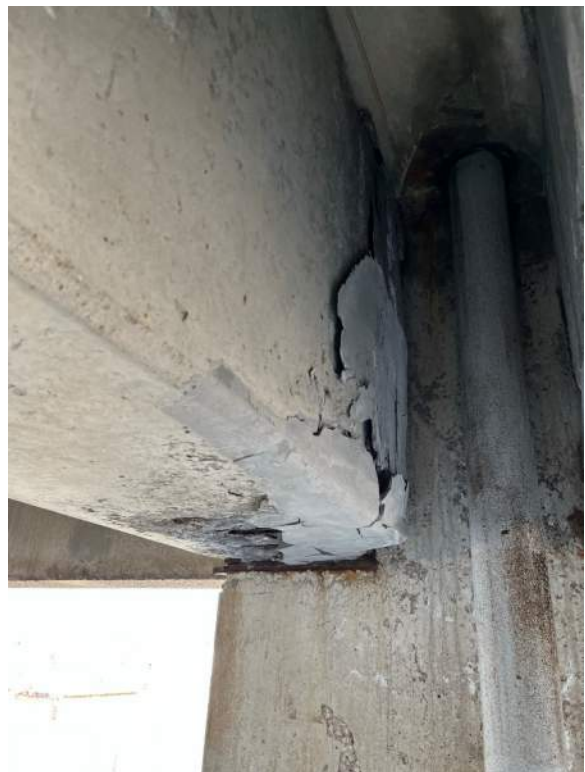
Photo 32: Spall at joist stem bearing at previous repair mortar and corroded bearing plate.

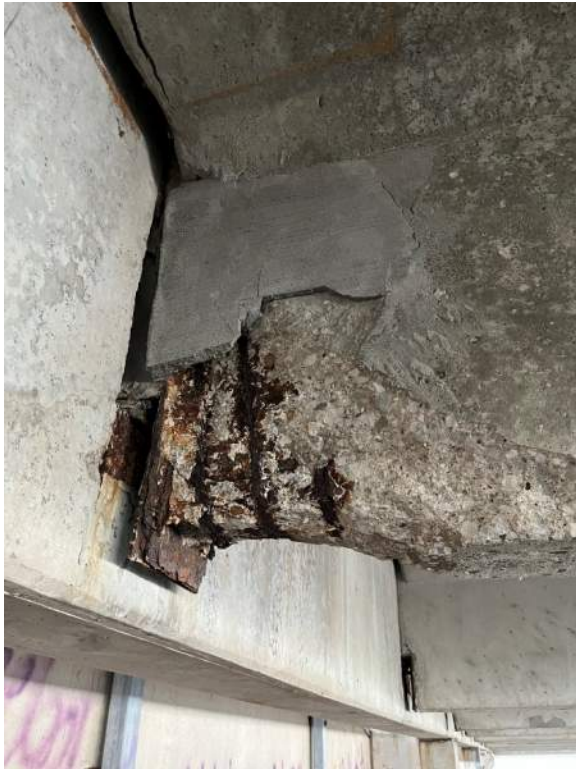
Photo 33: Typical severe spall at joist stem. Exposed corroded reinforcing and embed plate. Spalling of previous repair mortar observed.

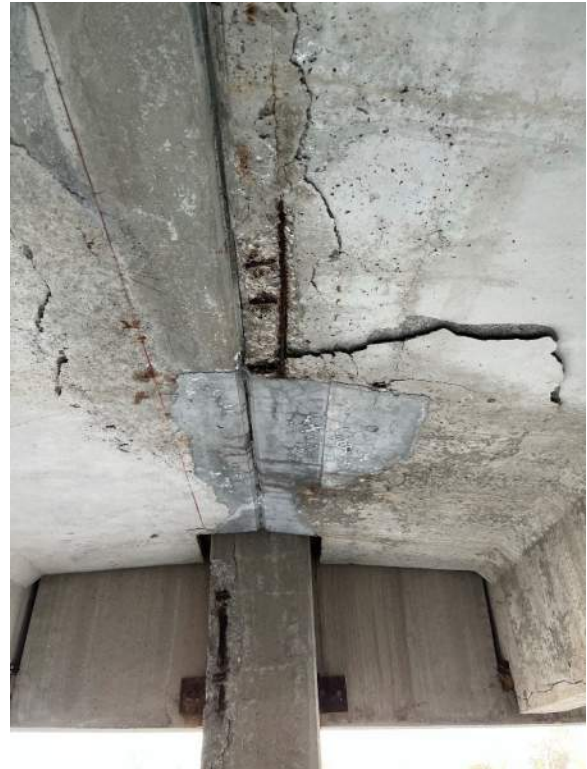
The Precast T's slabs/flanges are typically in Fair to Poor Condition and have experienced significant systemic deterioration at joints (See Photos 34 - 40). A multitude of previously repaired areas were observed. The wide nature of these precast elements with centralized bearing is prone to rocking. This causes stress at the existing embedded steel T to T connectors. This stress in conjunction with the failed waterproofing system has resulted in failure and spalling at many of the T to T connectors. A substantial amount of soffit spalling was observed along the precast joints including extensive piles of debris on the slabs below illustrating the risk to occupants from falling concrete. Approximately 50 locations with substantial delaminated concrete observed on the parking deck floor indicate an accelerated rate of decay since demolition/stop in use (See Photos 41 & 42).

Photo 34: Spall at column and at joist flanges. Spalling of original and repair materials observed. Exposed corroded reinforcing observed.

To prevent cracking and spalling at the precast T joints, the installation of FRP biscuits is recommended. These post installed T to T connectors are corrosion resistant and prevent rocking of the precast T's that is causing the systemic spalling observed along the joints. Preventing movement at these joints will provide greater efficacy of the epoxy overlay waterproofing system.

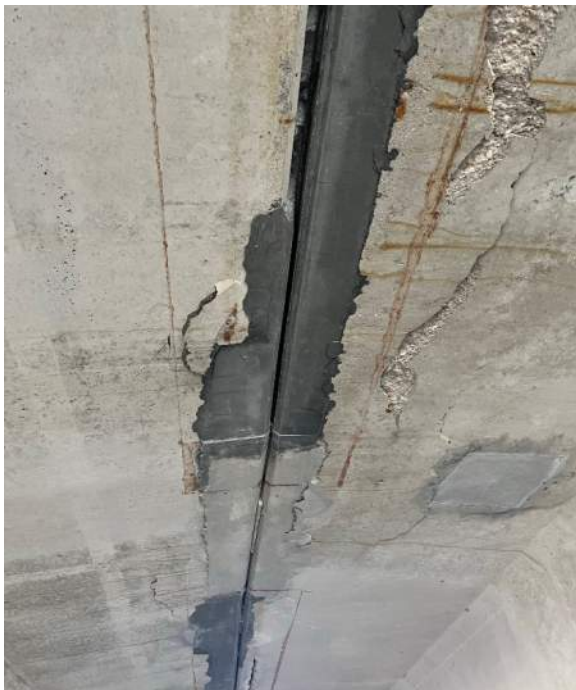
Photo 35: Typical soffit spall at Precast T joint. Spalling of original and repair materials observed.

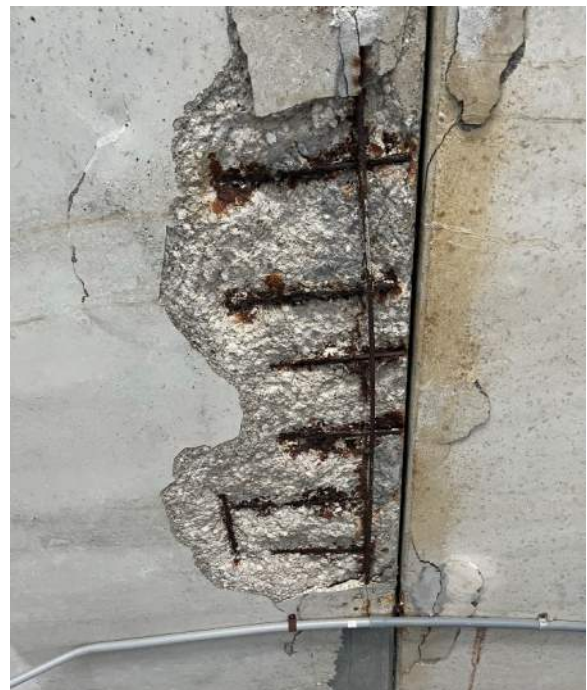
Photo 36: Severe spall of soffit/precast flange. Highly corroded exposed reinforcing.

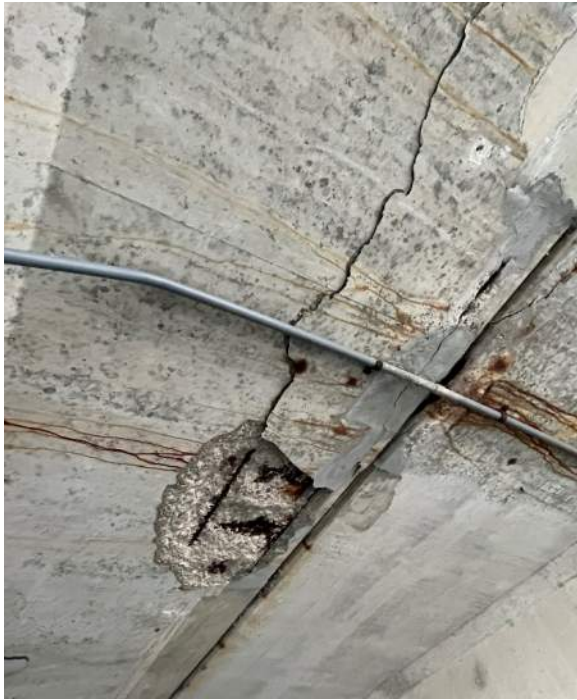
Photo 37: Typical soffit spall at Precast T joint.

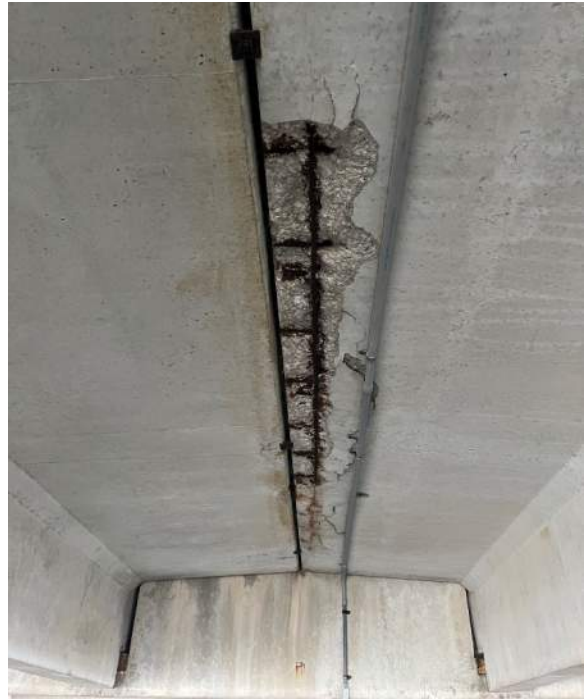
Photo 38: Typical soffit spall at precast T joint.

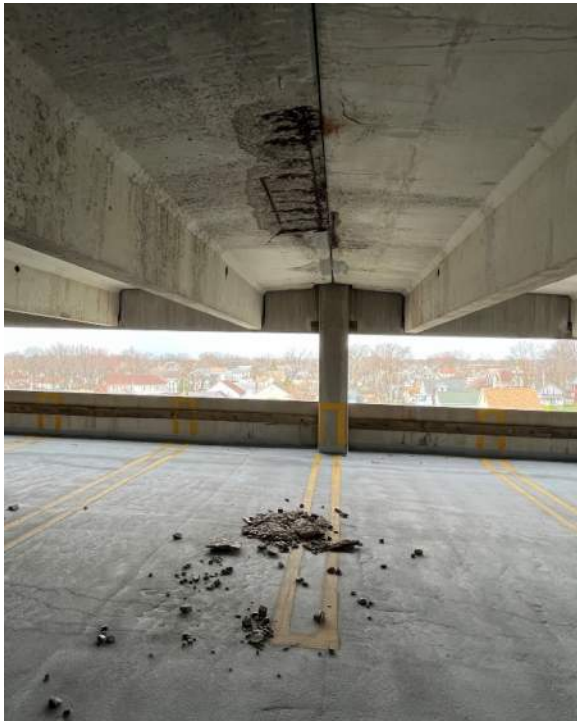
Photo 39: Soffit spall with concrete debris below.

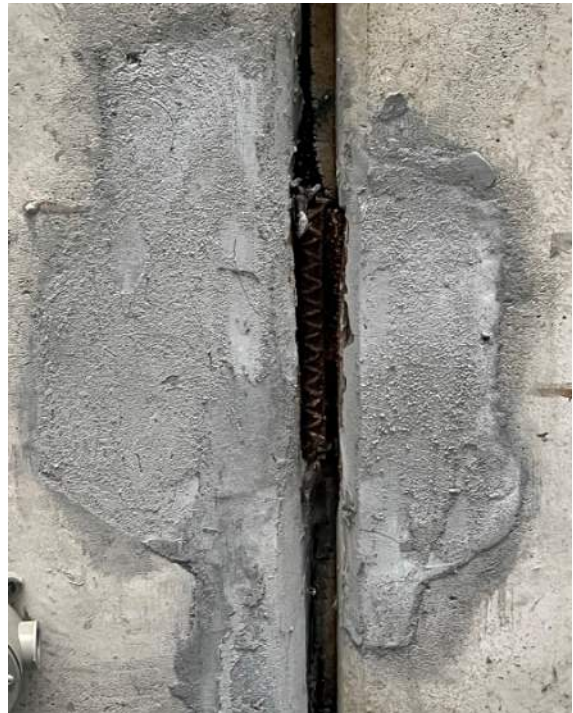
Photo 40: Precast T flange embedded steel connection.

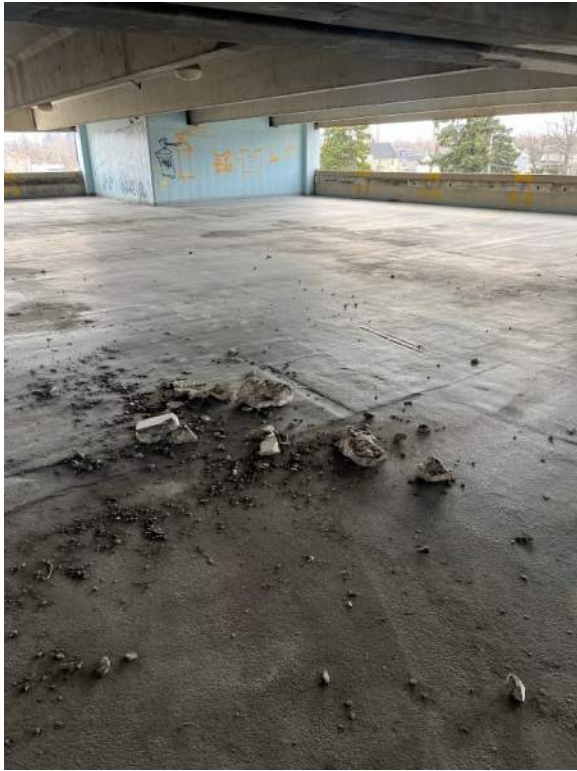
Photo 41: Typical debris on slab at overhead spalls.
Size of falling concrete debris represents safety hazard.

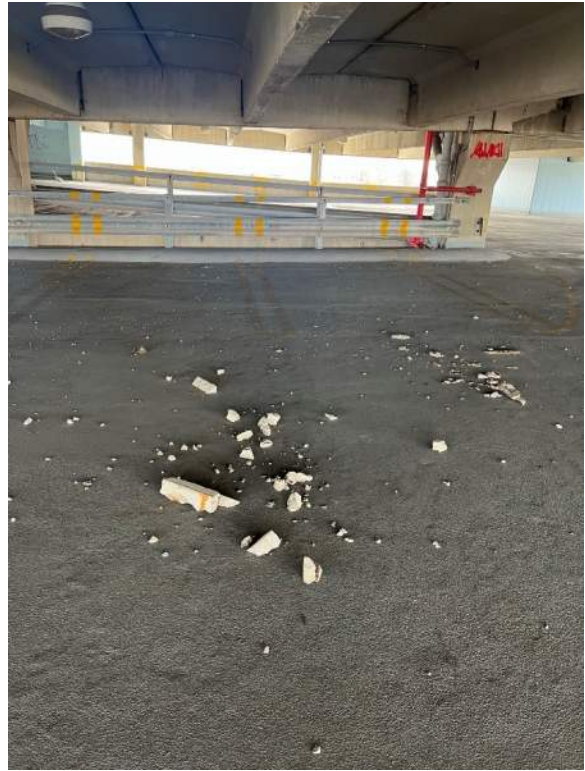
Photo 42: Typical debris on slab at overhead spalls.

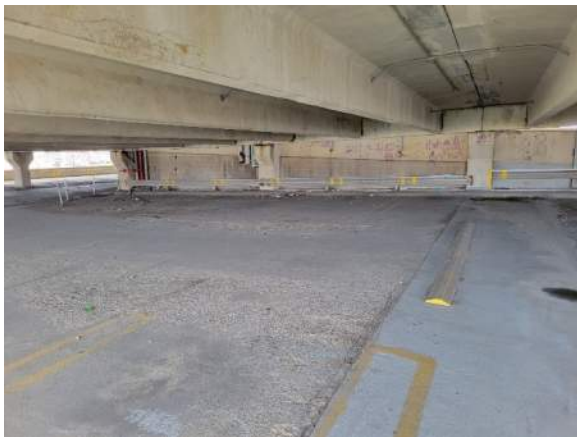
The lower levels of parking deck were observed to have extensive scaling on the deck slabs top surface. In addition, cracking and the presence of failed sealants were observed (See Photos 43 & 44). The upper levels of the parking deck have had a newer epoxy overlay added to the deck as a protective layer and waterproofing system. The thickness of the system and brittle nature of the epoxy overlay system resulted in cracking along many of the T to T joints allowing water to infiltrate into the joint causing spalling through expansion of reinforcing steel and connectors as well as through expansion of water during freeze thaw cycles. The presence of chlorides from de-icing chemical exacerbates this process. Areas of cracking and failed sealants were observed as well as select areas of delaminated coating. In general, the epoxy overlay system is in poor condition (See Photos 45 - 49).

Photo 43: Scaling of top of slab at lower section of garage. Start of newer coated area.

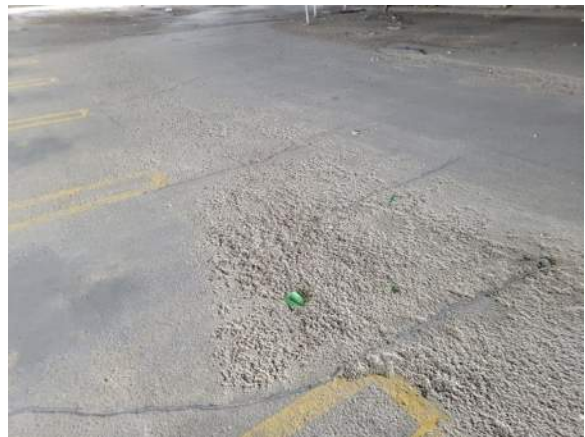
Photo 44: Heavy scaling of top surface of parking deck slab surface. Cracks with failed sealants observed.

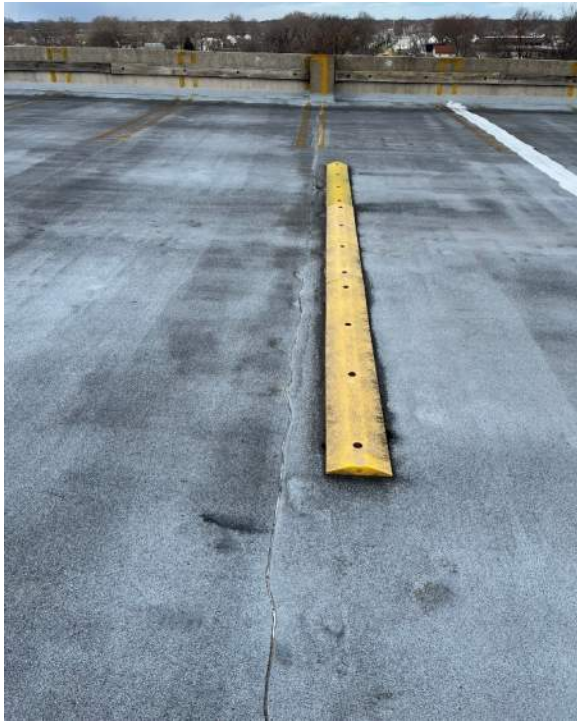
Photo 45: Typical condition of epoxy overlay. Failed sealant at T to T joint crack.

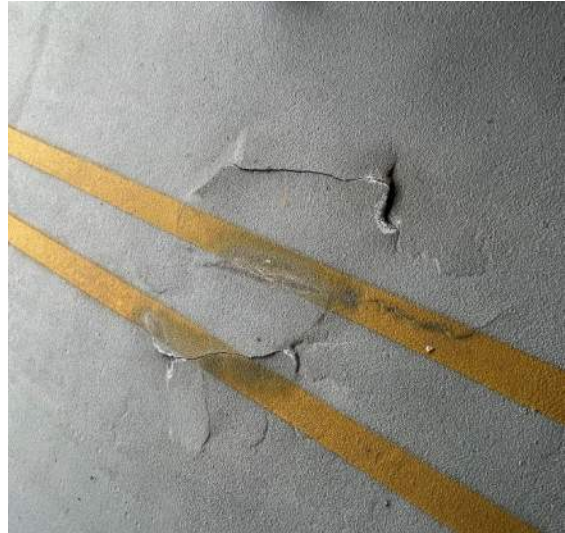
Photo 46: Delaminated epoxy overlay with probable concrete spall below.

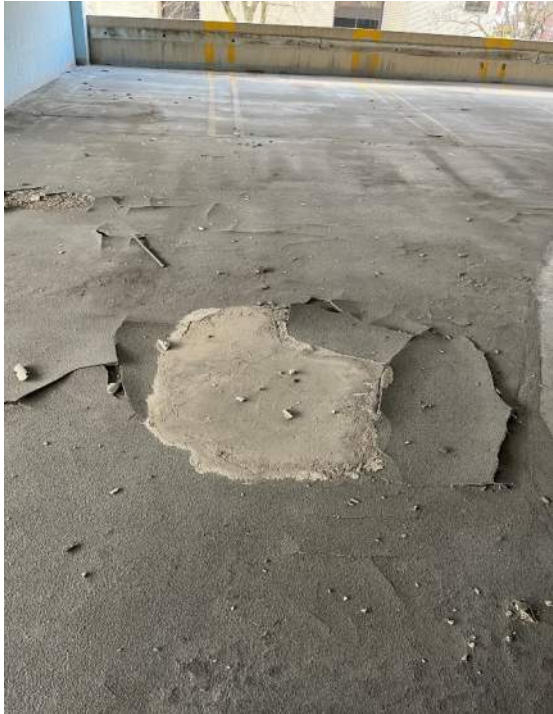
Photo 47: Delaminated epoxy overlay coating.

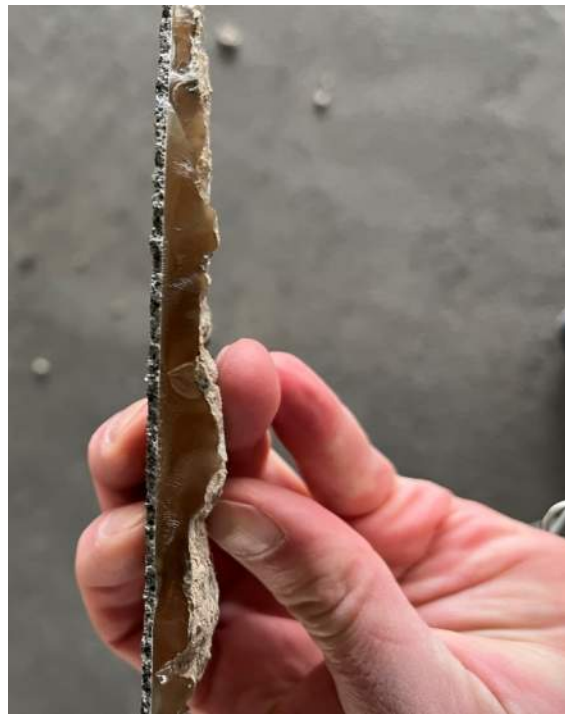
Photo 48: Epoxy overlay system cross section. Epoxy thickness is the result of going over highly scaled slab.

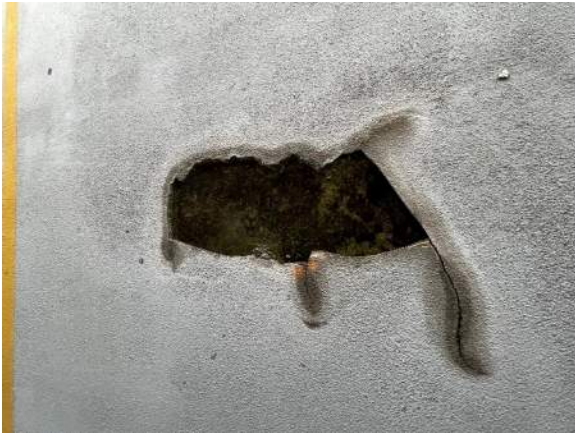
Photo 49: Spall in deck with standing water.

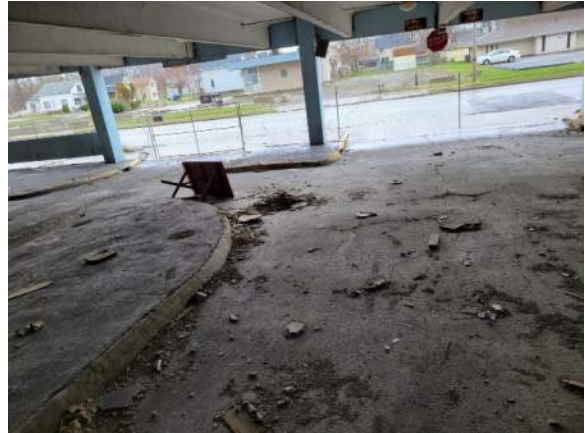
At the entry/lower ramp area of the parking structure the slab is on grade. Moderate deterioration of slab, wall, and curbs was observed. In addition, parking gates were observed to not be present for future use (See photos 50 & 51). New gates and payment systems would be required for use of the structure.

Photo 50: Entry area at slab on grade.

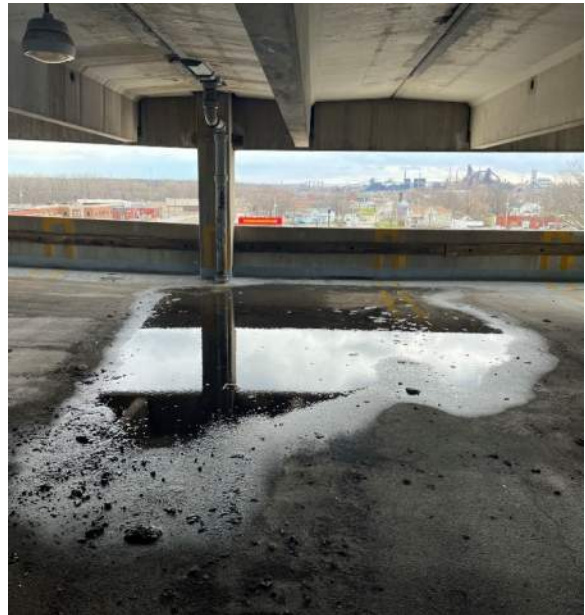
Areas of significant ponding water were observed indicating that at select locations, additional long term exposure to water and freeze thaw cycles may be further accelerating deterioration of the parking decks slabs due to lack of drainage (See Photos 52 & 53). Additional exposure to water is also occurring due to damaged drain boxes and pipes. Instances of broken pipes and spalling around drains were observed (See Photos 54 - 56). A full condition assessment of drainage systems is not included within the scope of this report.

Photo 52: Observed area of ponding below drain above.

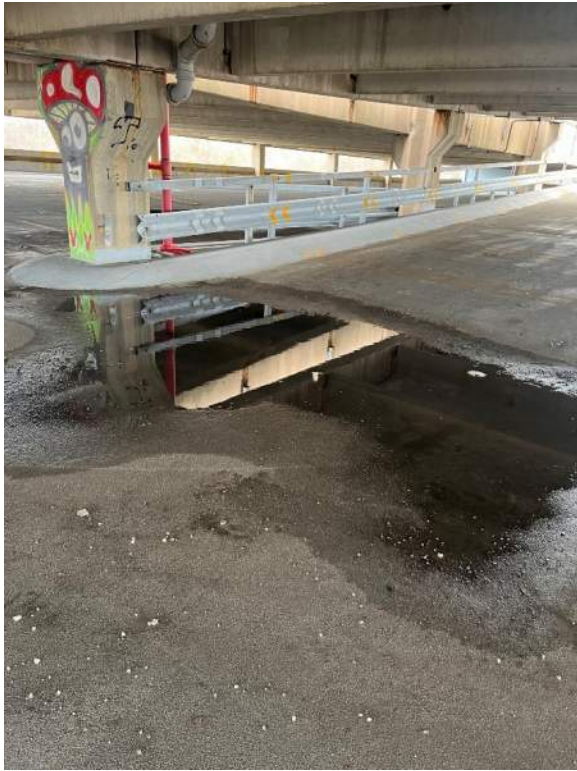
Photo 53: Observed area of ponding below drain above.

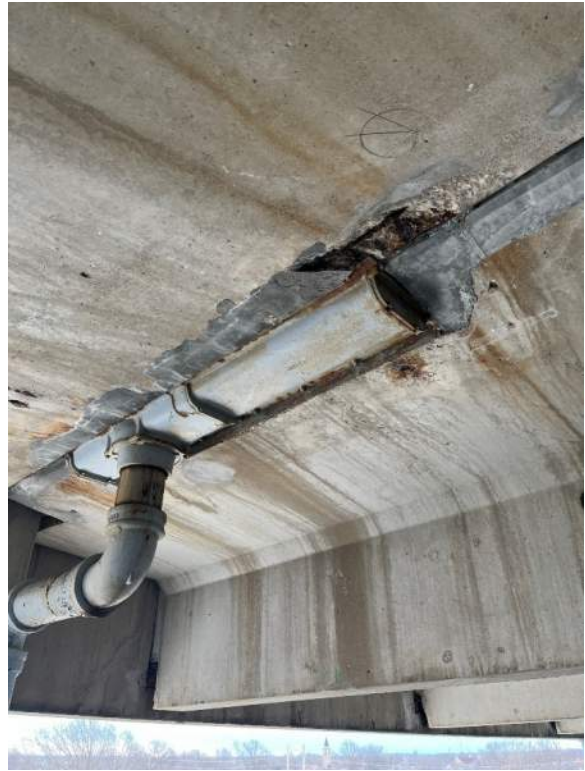
Photo 54: Spalling and deterioration of concrete at trench drain box. Exposed corroded reinforcing and previous repair materials visible.

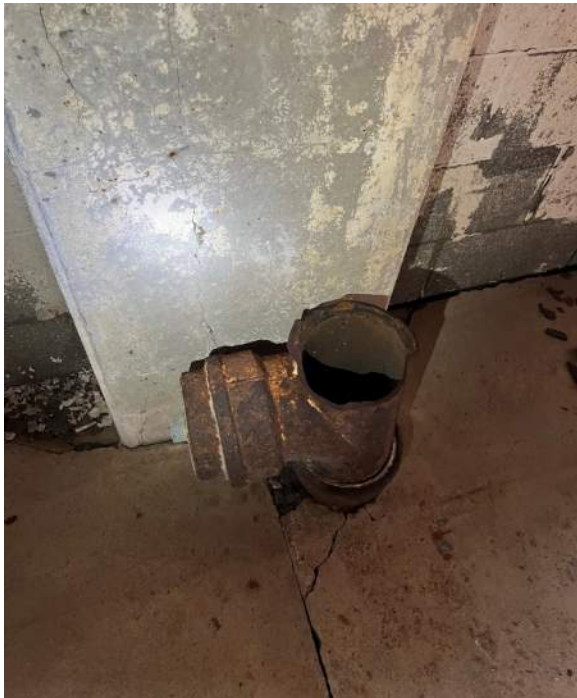
Photo 55: Broken iron drainpipe.
