Structural Hazzard Assessment Report

Condition Assessment of Parking Garage and Stair/Elevator Tower
at Partially Demolished St. Joseph Hospital and Health Center
205 West 20th Street Lorain, Ohio.

Prepared for
The City of Lorain
May 4, 2022

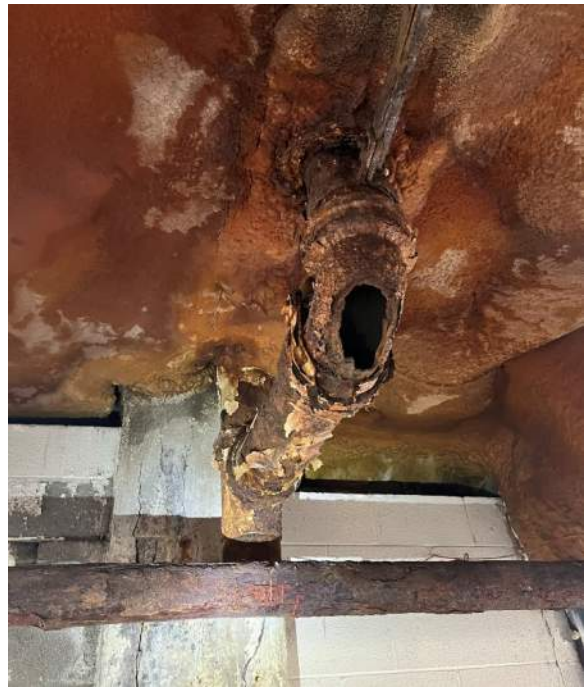
Photo 56: Corroded through drainpipe with missing vertical section at occupied area.

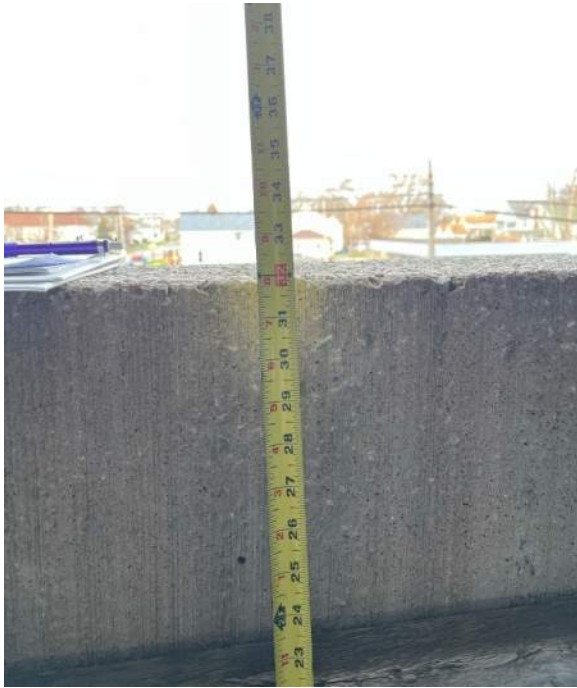
In addition to the structural observations noted above, the parking structure was also observed to have deficient pedestrian guard systems at the exterior perimeter and along the interior ramps. The typical barrier walls are 32" tall rather than the code defined 42" (See Photos 57 - 59). This would require modification with new steel rails at both the exterior perimeter and between the deck ramp section along the center line of the garage. Hand/guard rail modifications would also be required at the stair tower for proper elevation and closure. These modifications are required for fall protection of pedestrians within the parking and stair areas.

Photo 57: Observed height of perimeter guard walls less than required by code (32" observed, 42" required) for pedestrian fall protection.

Reuse of the structure would require updating the pedestrian guard system at the perimeter of the garage and at the gap between slabs at the interior ramp.

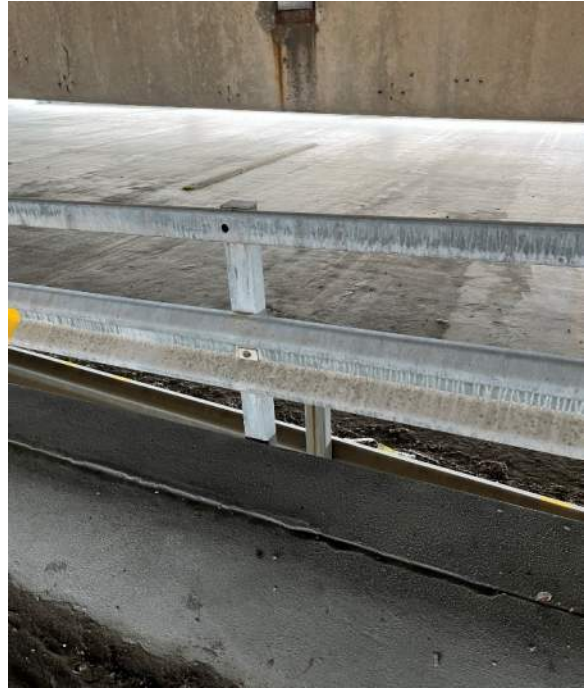
Photo 58: Improper closure at interior ramp vehicular guard rails. Fall Hazard.

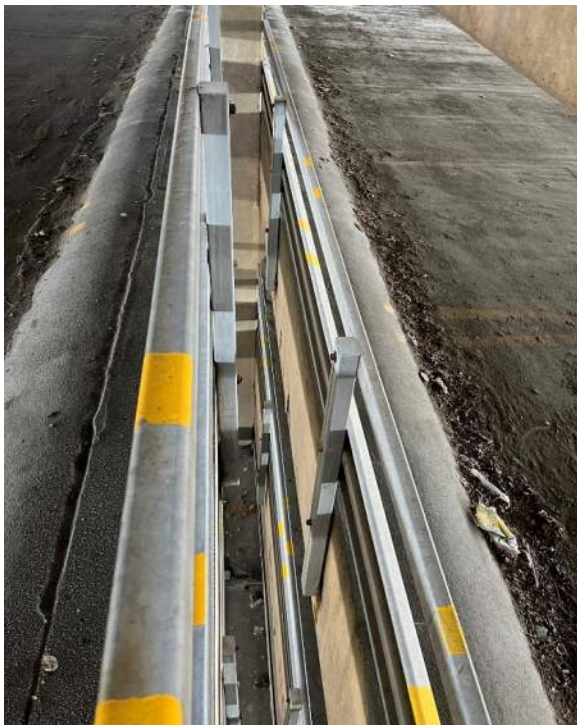
Photo 59: Fall hazard at interior ramps gap between slab sections.

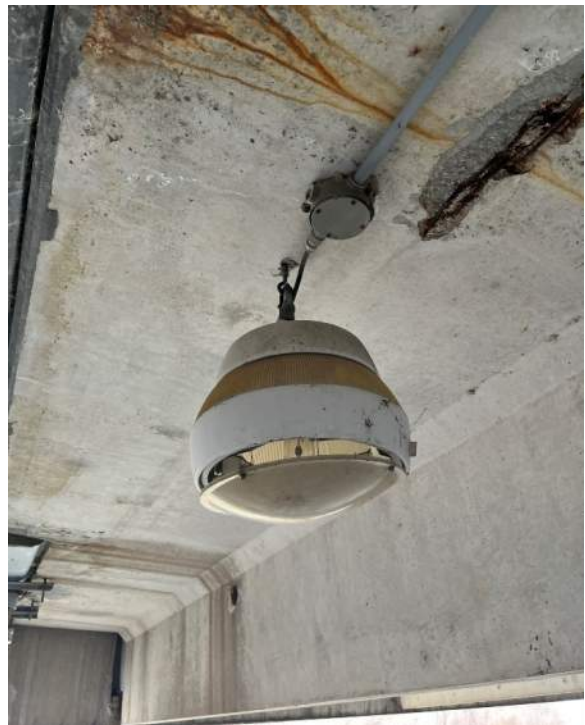
In addition, while not included directly within the scope of this report several the electrical system, lighting, and mechanical systems appear to be in Poor to Obsolete condition. The existing lighting system is composed in incandescent lighting with areas observed to be damaged or missing (See Photos 60 - 66).

Photo 60: Typical light fixture.

Electrical upgrades would be required throughout the garage, stair/elevator tower, and occupiable areas at level 1. The current electrical fixtures are obsolete and beyond their usable life. Many elements were observed to be damaged or missing. A complete electrical upgrade would likely be required. Costs for this work are not included in this report.

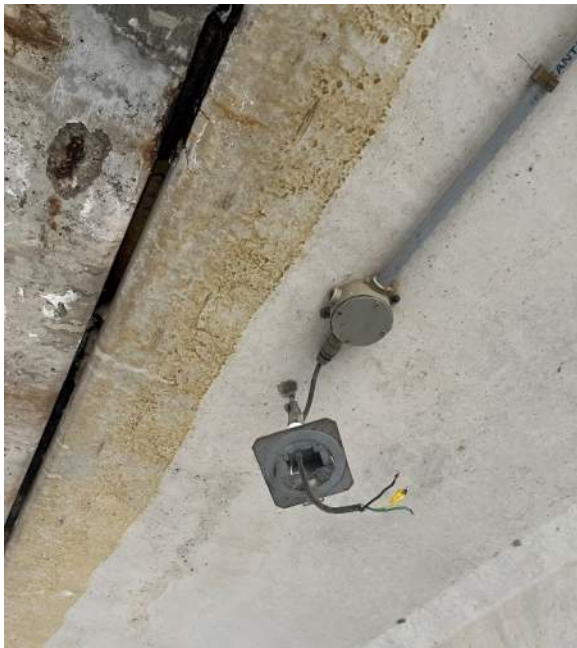
Photo 61: Missing light fixture with exposed wires.

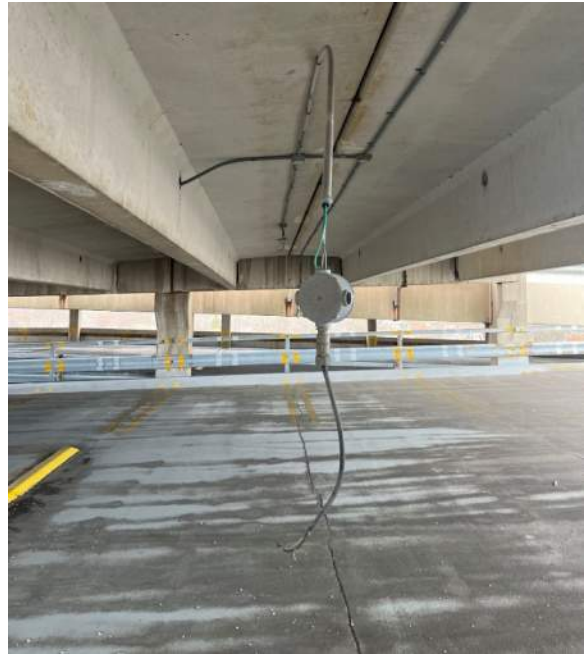
Photo 62: Missing light fixture with detached box and exposed wires.

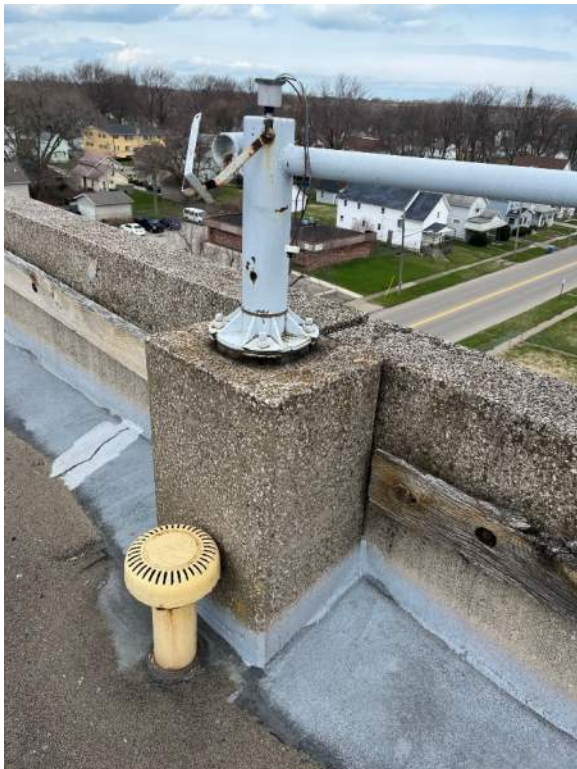
Photo 63: Damaged rooftop light fixture with exposed wires.

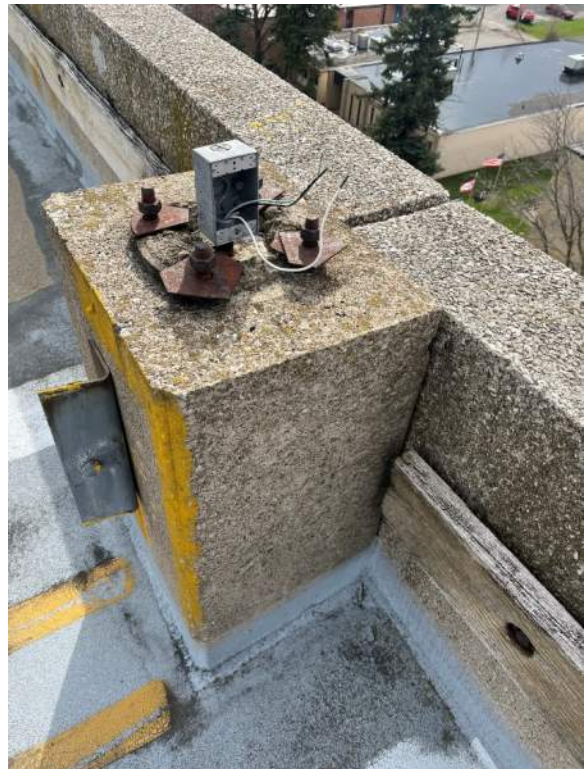
Photo 64: Missing rooftop light fixture with exposed wires.

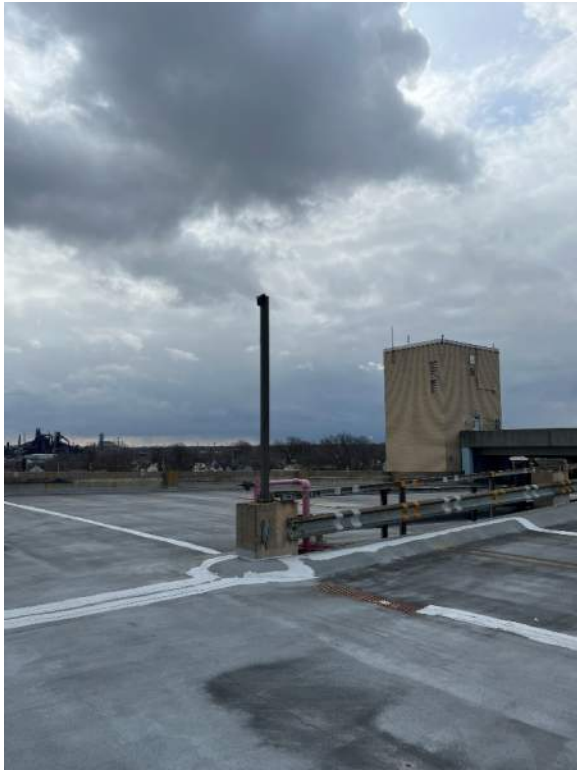
Photo 65: Missing light on post at top level.

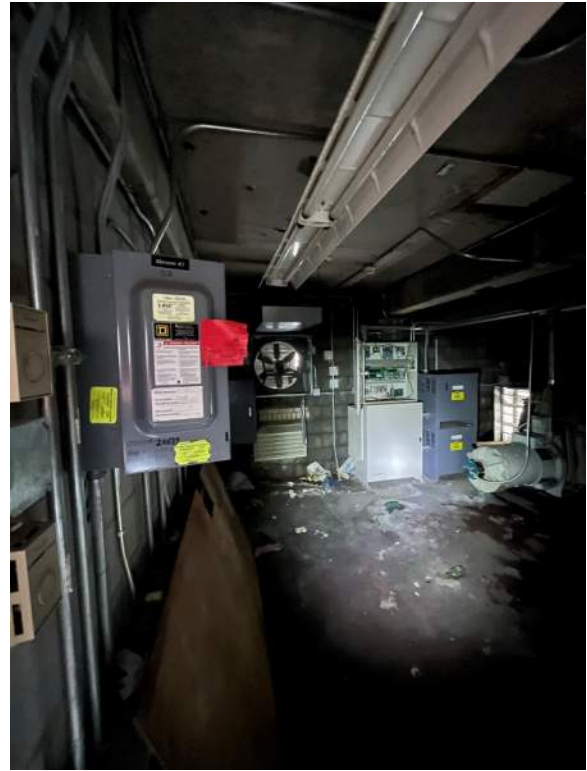
Photo 66: Existing condition of elevator machine room.

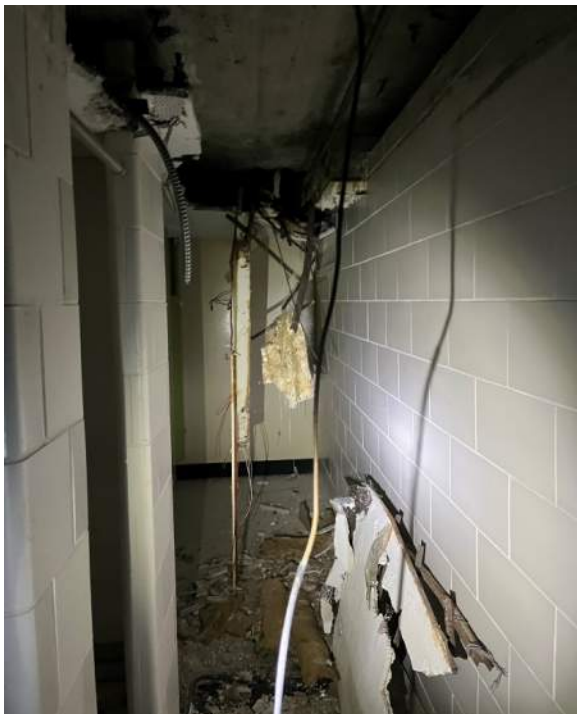
Photo 67: Partially demolished interior fixtures at previously occupied area. Exposed electrical wires and falling debris hazards.

Finalized demolition and renovations of the occupiable/non-parking area would also be required. This may include some required abatement. Recommendations for mechanical, electrical, and architectural elements for this area are beyond the scope of this report.

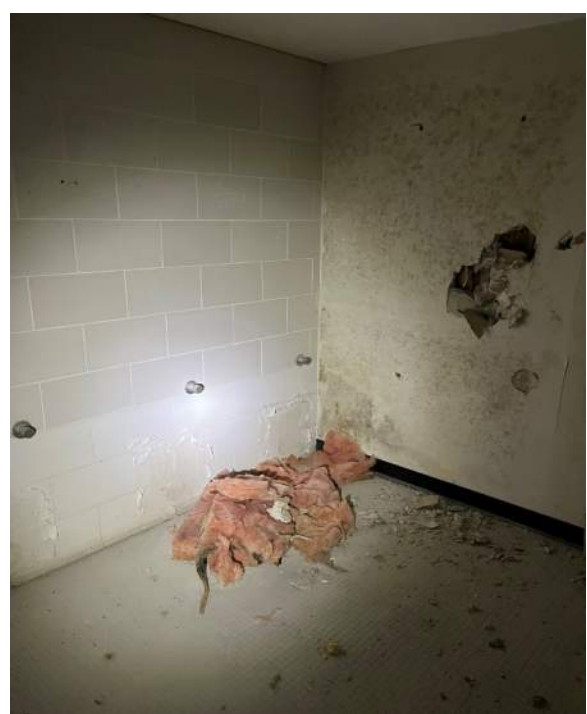
Photo 68: Existing condition of previously occupied area. Mold probable on drywall finished areas.

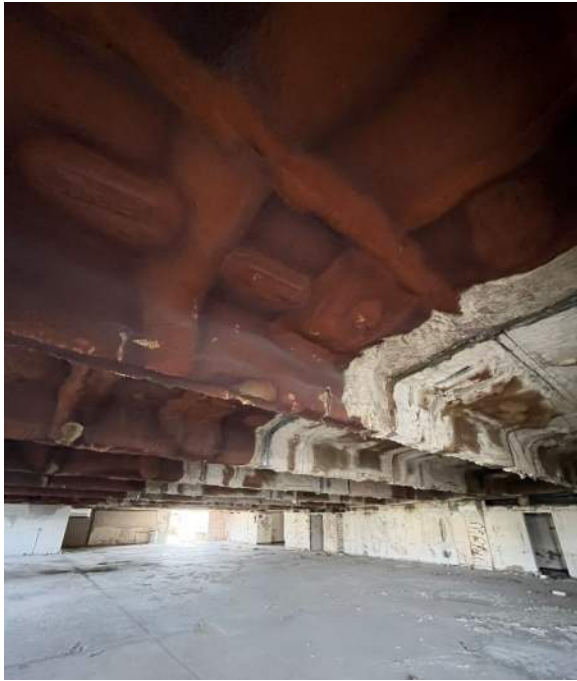
Photo 69: Typical condition of previously occupied area. Water intrusion evident within insulation. Structure above not visible.

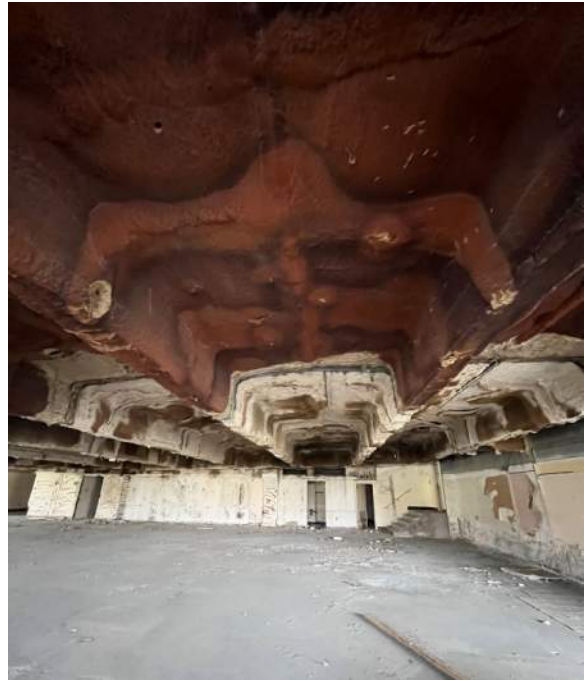
Photo 70: Typical condition of previously occupied area. Water intrusion evident within insulation. Structure above not visible.

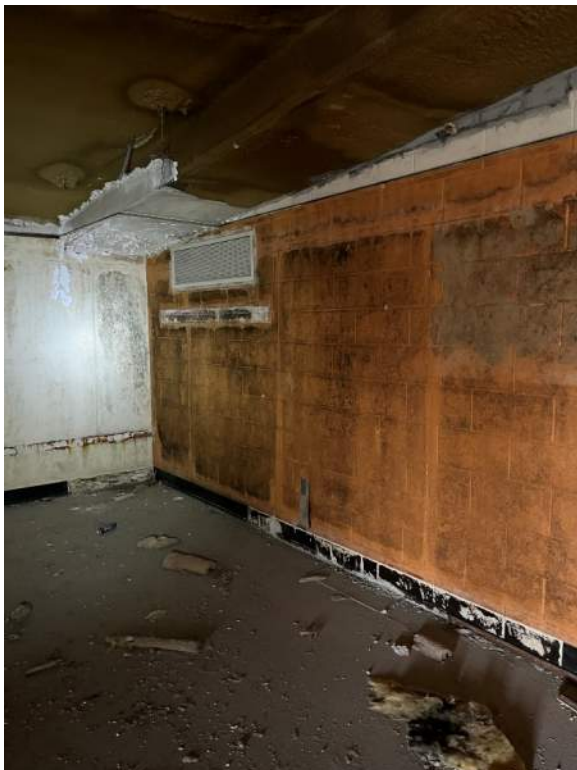
Photo 71: Typical condition of previously occupied area. Mold probable on CMU wall.

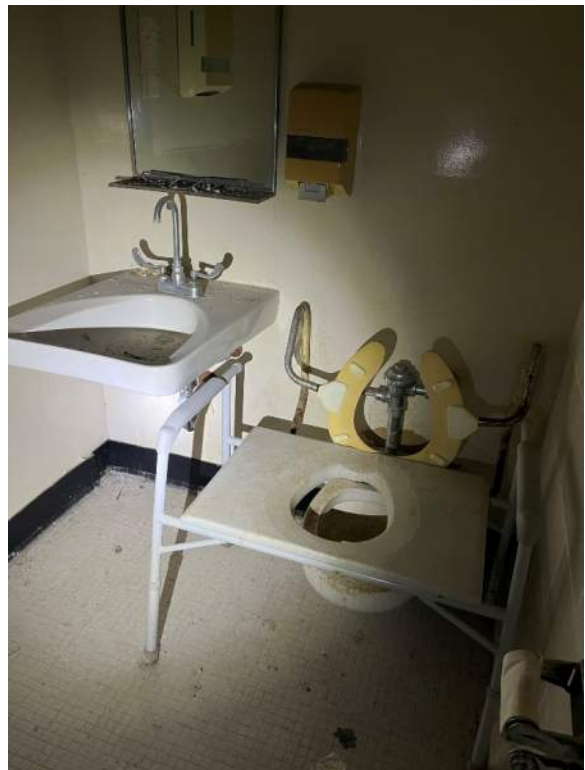
Photo 72: Existing condition of previously occupied area restroom.
