Structural Hazzard Assessment Report

Condition Assessment of Parking Garage and Stair/Elevator Tower
at Partially Demolished St. Joseph Hospital and Health Center
205 West 20th Street Lorain, Ohio.

Prepared for
The City of Lorain
May 4, 2022

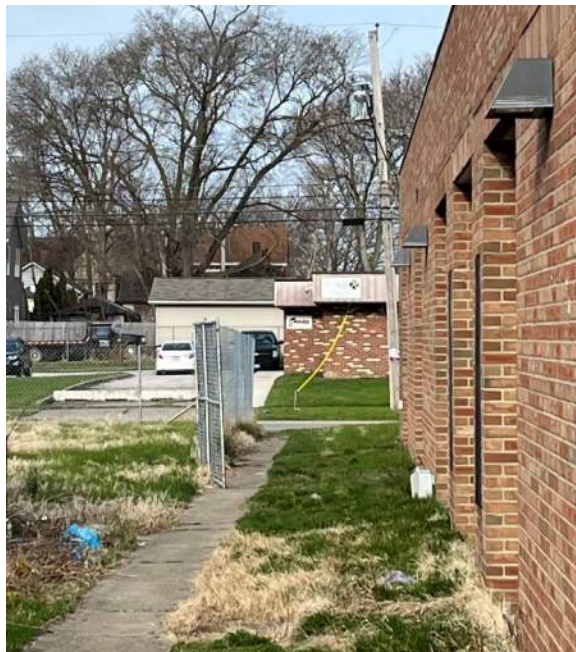
Safety concerns associated with the overall Site include unintended access through fence openings (See Photos 2 & 3), unsatiable debris and pits, partially demolished structures with falling debris or dangerous rubble (See Photos 4 - 8). Pedestrians were observed traversing through the site through the two openings in the fence on the north side of the site. In addition, several observed objects and conditions within the parking structure and stair tower indicate that individuals have occupied the area after demolition.

Photo 3: Incomplete closure of fence at adjacent building to the north of the site.

The Site and Elevator tower safety concerns discussed above should be addressed Immediately to prevent Hazards to Human Life. See Recommendations section below for additional information.

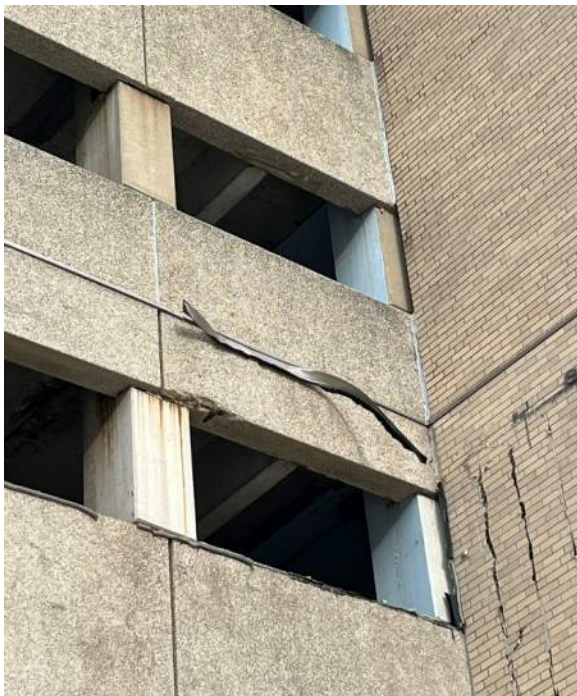
Safety concerns associated with the Elevator/Stair Tower include fall hazards at the elevator tower openings due to accessible doors and broken out window systems and fall hazard at the 2nd floor exit to the stair tower at previous entry into hospital. Several of the doors from the garage to the elevator lobby were observed to have been welded shut however 3 were observed to be operable due to damage at the hinges or lock plates resulting in access to the area. In addition, several building elements were observed to be dislodged at the perimeter of the Elevator/Stair tower and at the east face of the garage along the hospital demolition line. These include the window systems and miscellaneous building elements at the

adjacent east face of the parking structure. These elements could fall to grade below resulting in site safety risks. See Photos 9 - 17 for typical condition of safety elements described above at the Elevator/Stair Tower.

Photo 11: Remaining portion of low roof flashing at east face of garage could fall.

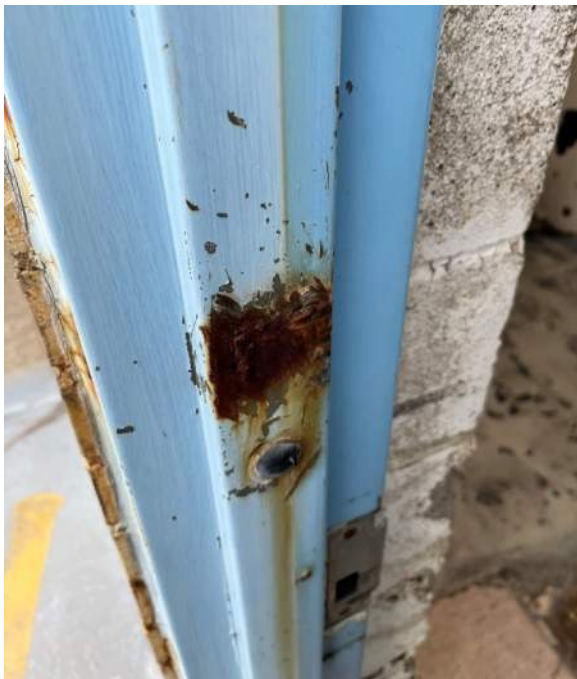
Photo 15: Detached weld plate at door jamb.

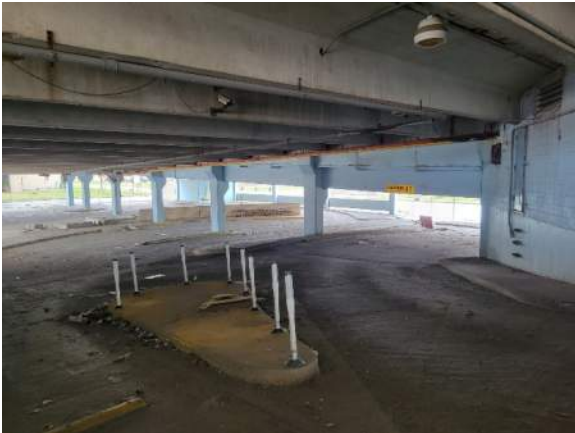
At the entry/lower ramp area of the parking structure the slab is on grade. Moderate deterioration of slab, wall, and curbs was observed. In addition, parking gates were observed to not be present for future use (See photos 50 & 51). New gates and payment systems would be required for use of the structure.

Photo 51: Entry/ramp area.
